**PERFLUORINATED COMPOUNDS PRELIMINARY ASSESSMENT  
SITE VISIT REPORT**

**WISCONSIN AIR NATIONAL GUARD  
TRUAX FIELD  
DANE COUNTY REGIONAL AIRPORT  
MADISON, WISCONSIN**

**December 2015**

**BB&E, Inc.**  
**December 2015**

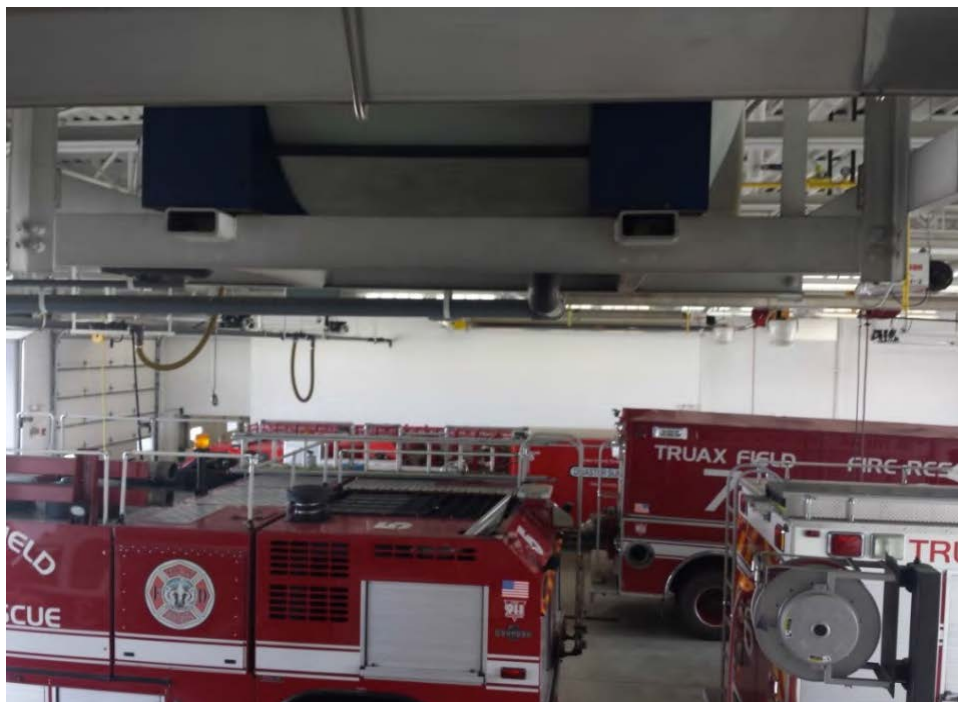
Photo 1: Overhead foam fill at Fire Station (Building 430).

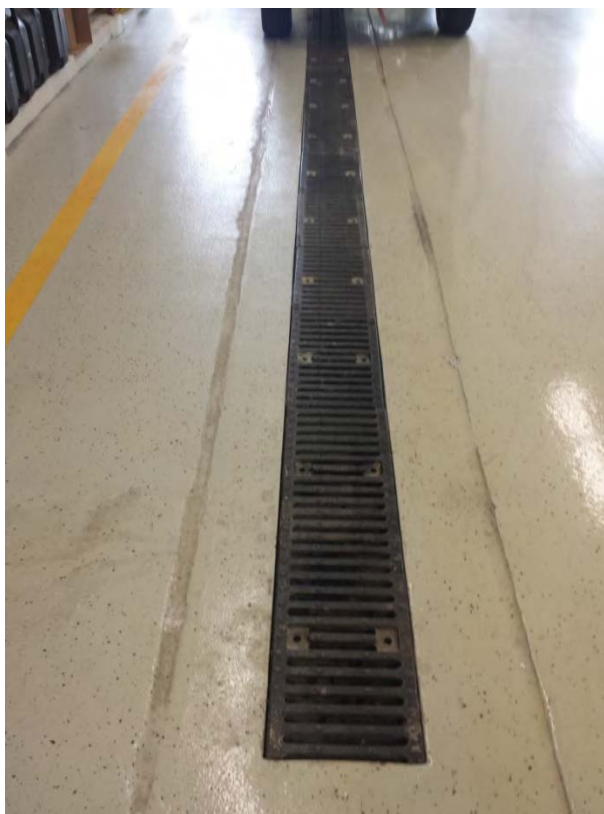
AFFF has been used by the WIANG FD for at least 20 years, and has been stored in Building 430 since it was built, circa 1995. Currently, there are approximately 471 gallons (gal) of AFFF carried in FD trucks and approximately 821 gal of AFFF serving as a backup supply, stored in the fire station. AFFF is transferred to vehicles within the fire station via overhead fill. Also, FD vehicles are washed within the fire station or the outside truck bays when necessary. There are trench drains located in the fire station and downgradient of the truck bays; therefore, any AFFF releases due to vehicle washing would be captured by the trench drains, which discharge into the sanitary sewer system.

Photo 2: Trench drain (one of several) in the Fire Station (Building 430)

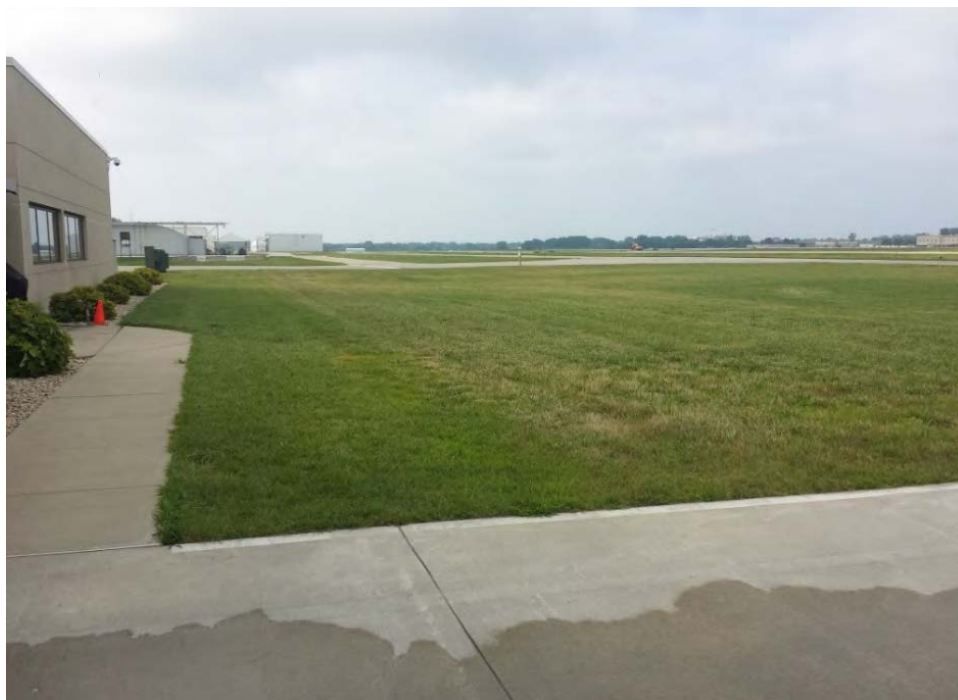
The AFFF nozzle systems on FD vehicles have been tested every six months. Nozzle tests are conducted in the grassy areas on the northwest and southwest (see Section 3.1.3) sides of Building 430. Any AFFF released in porous green spaces has the potential to seep into the subsurface and groundwater.

Photo 3: Looking south on west side of Fire Station (Building 430) where vehicle spray pattern tests are conducted.

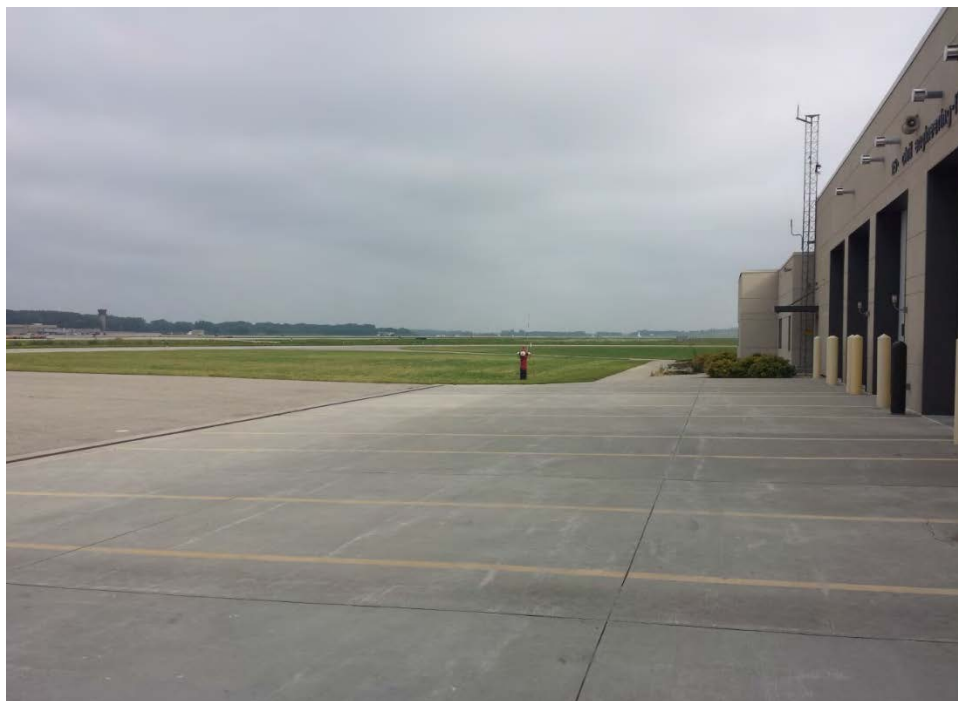
Photo 4: Looking north on west side of Fire Station (Building 430) where vehicle spray pattern tests are conducted.

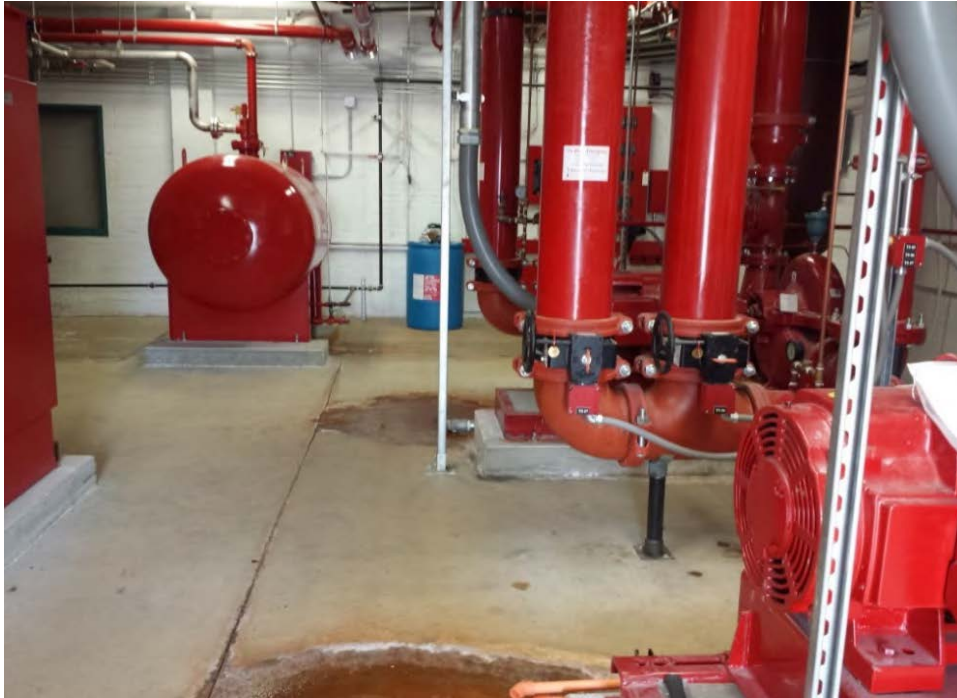
accidental release within the hangar would have been routed to the trench drains that historically led to an OWS which then discharged into the sanitary sewer system. The OWS was removed in 2009; no contamination was observed during removal (Leidos, 2015).

Photo 5: HEF storage (historically may have been AFFF storage) in the Mechanical Room of Hangar 400.

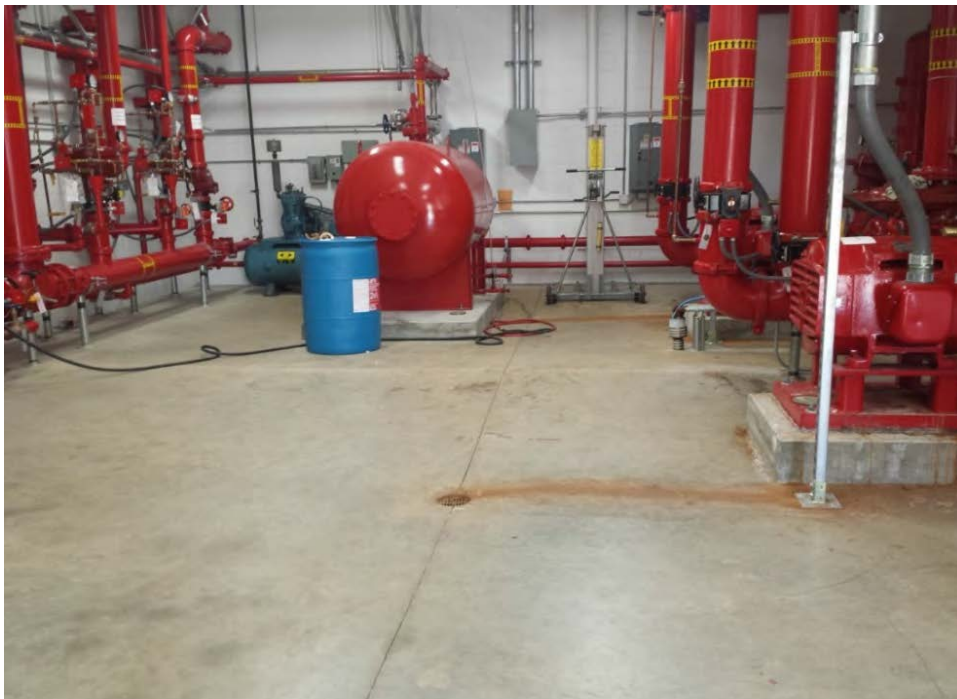
Photo 6: HEF storage (historically may have been AFFF storage) in the Mechanical Room of Hangar 406.

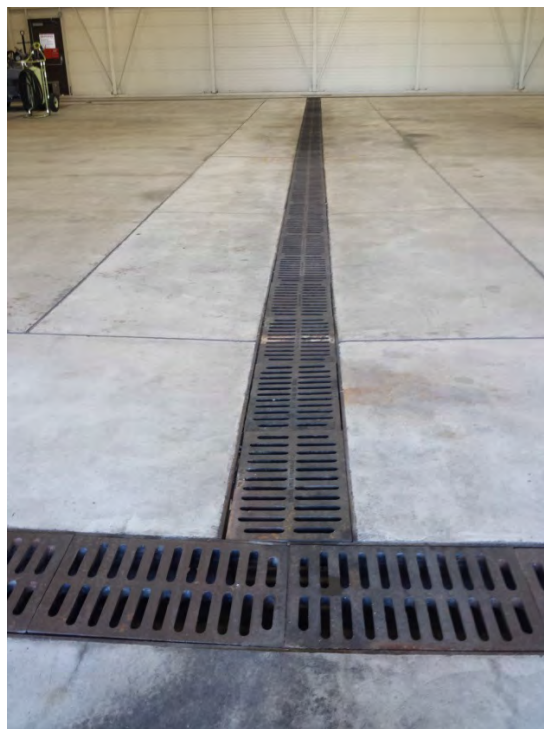
Photo 9: One of several trench drain inside Hangar 414.

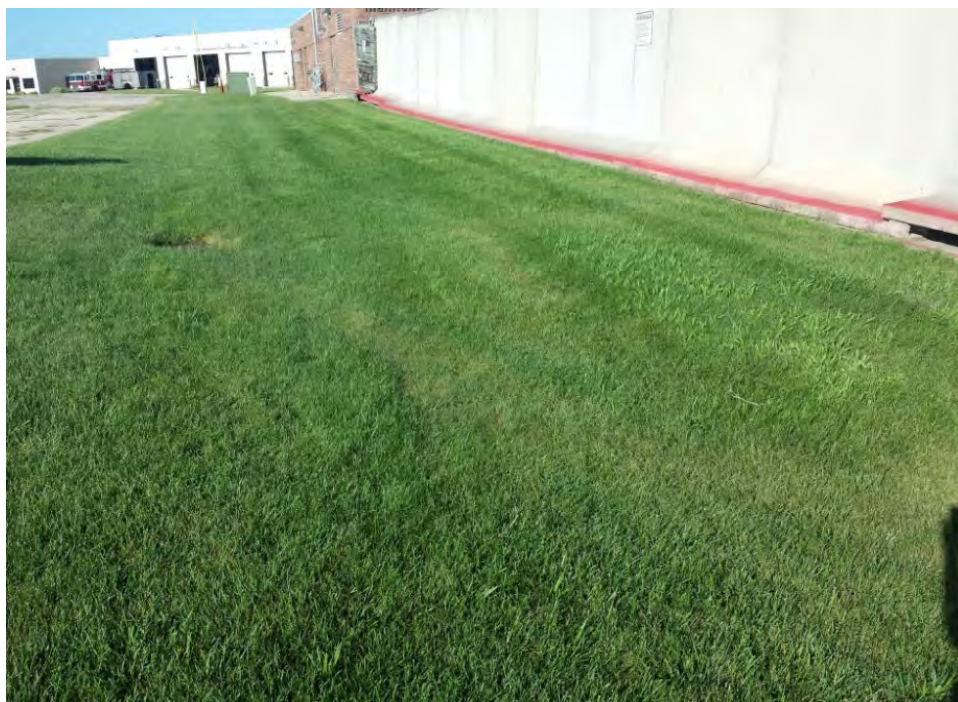
Photo 10: Drainage ditch between Buildings 414 and 431 – suspected area of 1981 fuel spill where foam was used.

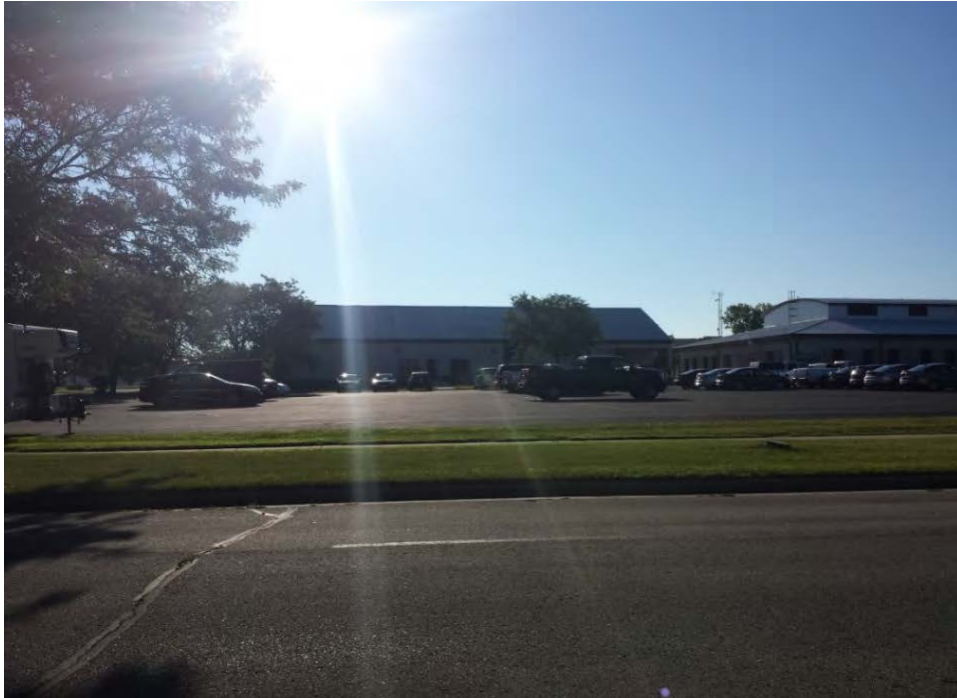
Photo 11: Looking east toward parking lot west of Building 503 where soil from 1981 fuel spill was placed on top of concrete pads and later disposed offsite.

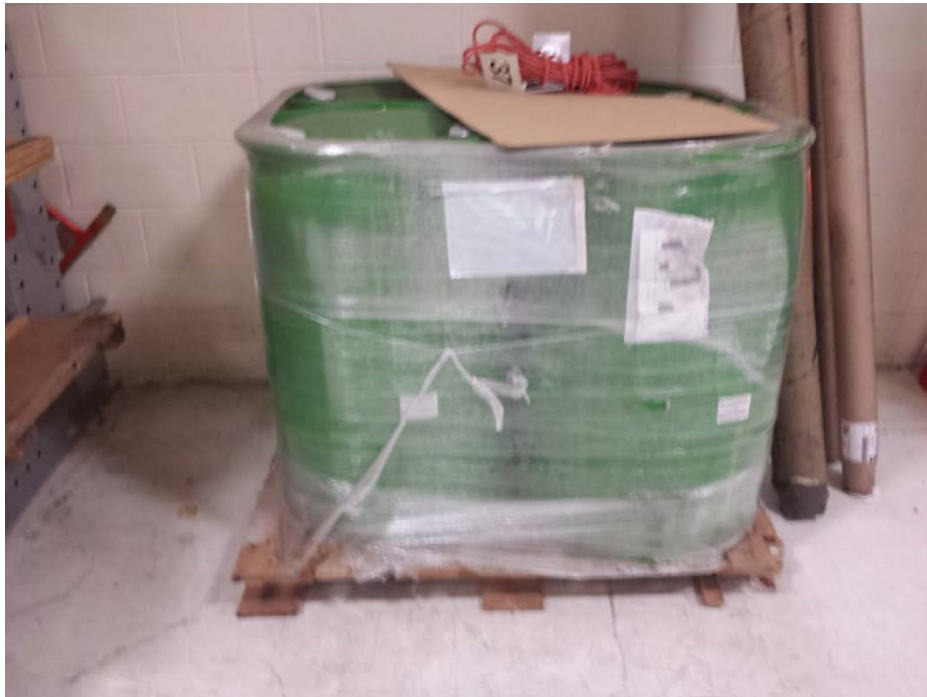
Four full drums of AFFF on a wooden pallet were observed during the PA site visit inside Building 510, which is where excess AFFF has been stored for an unknown amount of time. No secondary containment was provided for the drums; however, there were no visible floor drains or nearby mandoor doors or overhead doors to facilitate an outside release of AFFF. There are no known records or personnel knowledge of accidental AFFF releases at Building 510.

Photo 12: AFFF storage in Building 510 (Supply).
