**PERFLUORINATED COMPOUNDS PRELIMINARY ASSESSMENT
SITE VISIT REPORT**

**WISCONSIN AIR NATIONAL GUARD BASE
GENERAL MITCHELL INTERNATIONAL AIRPORT
MILWAUKEE, WISCONSIN**

December 2015

**BB&E, Inc.
December 2015**

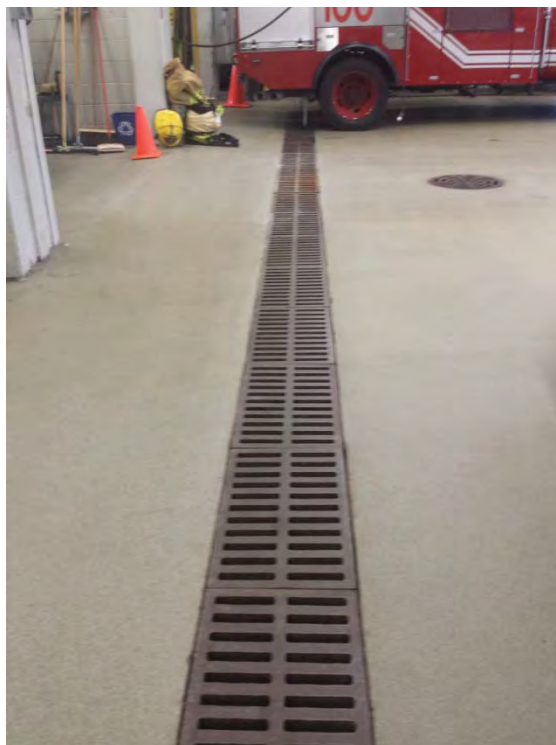
Photo 1: Trench drain at Building 621 (Fire Station).

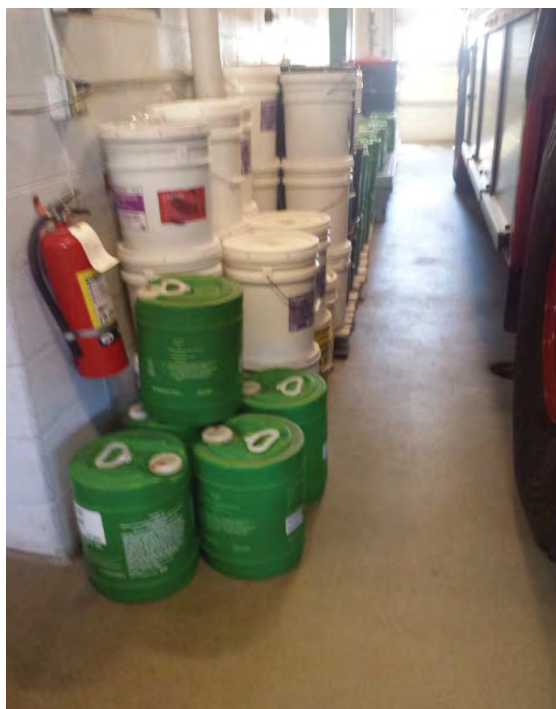
AFFF is stored in 5-gal containers and 55-gal drums by the WIANF FD at the current fire station which has been occupied since 1995. Three crash trucks and one engine use 3% AFFF currently; approximately 100 – 500 gals are carried per vehicle. Except for during emergency response, AFFF is transferred to vehicles within the fire station; trench drains within the station lead to an OWS which then discharges into the sanitary sewer system. When necessary, FD vehicles are washed within the fire station.

Photo 2: AFFF storage at Building 621 (Fire Station).

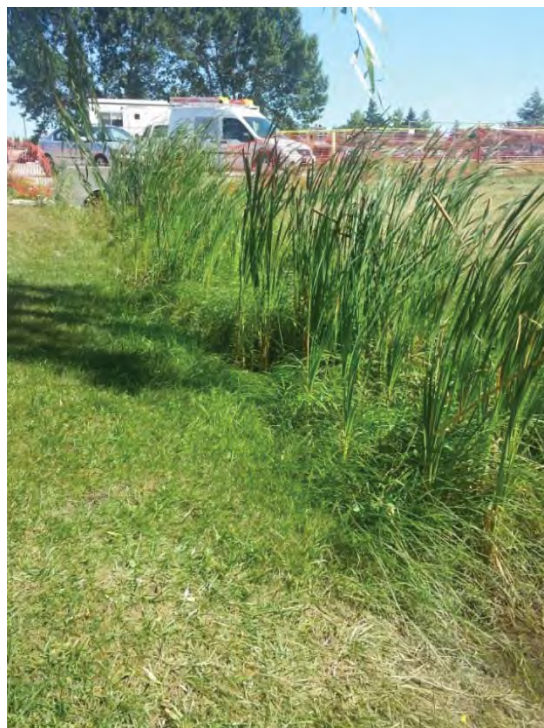
Photo 3: Base drainage ditch on the south side of Building 621 (Fire Station).

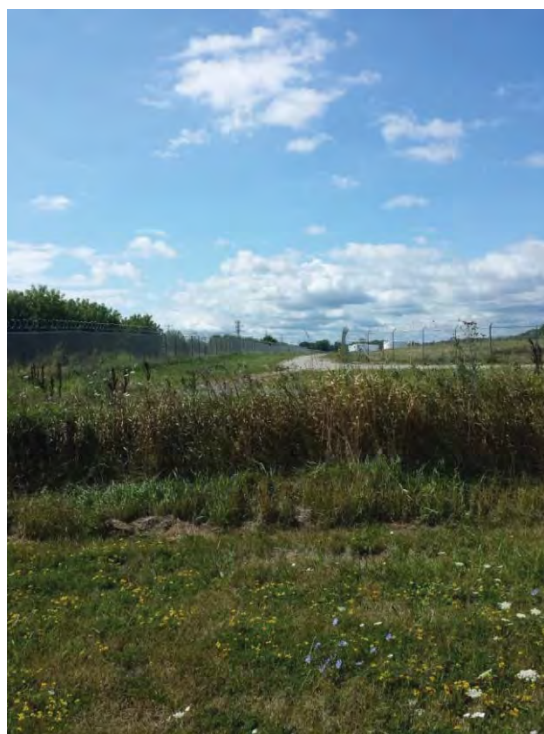
According to Base personnel, the WIANG FD may have used the gravel road on the east side of the landfill near Guard South for AFFF spray testing and calibration of vehicle equipment. This area is generally flat; any AFFF released may have flowed in a southerly direction along the road, or pooled in the standing water area observed during the PA site visit, which was located at the north end of the road near the Guard Central gate (see photo #4 in Appendix A and landfill topography map in Appendix C-3). Any AFFF released in porous green spaces has the potential to seep into the subsurface and groundwater.

Photo 4: Looking south toward Guard South (potential WIANG FD Equipment Testing Area).

4	WIANG FD Equipment Testing Area (Guard South)	42.936215°	-87.887060°	Possible FD equipment testing and calibration area. Possible AFFF discharges to surface soils. AFFF may have infiltrated into permeable ground soils.	Proceed to SI; focus on soil and groundwater.
5	WIANG FD Equipment Testing Area (Guard East)	42.943072°	-87.883627°	Possible FD equipment testing and calibration area. Possible AFFF discharges to surface soils. AFFF may have infiltrated into permeable ground soils.	Proceed to SI; focus on soil and groundwater.
6	Hangar 208	42.943284°	-87.886341°	Fire suppression system supplied with AFFF. Any AFFF releases likely entered the sanitary sewer; however, outside releases to the apron may have occurred.	Proceed to SI; focus on soil and groundwater at the downgradient edges of the apron based on surface drainage patterns.

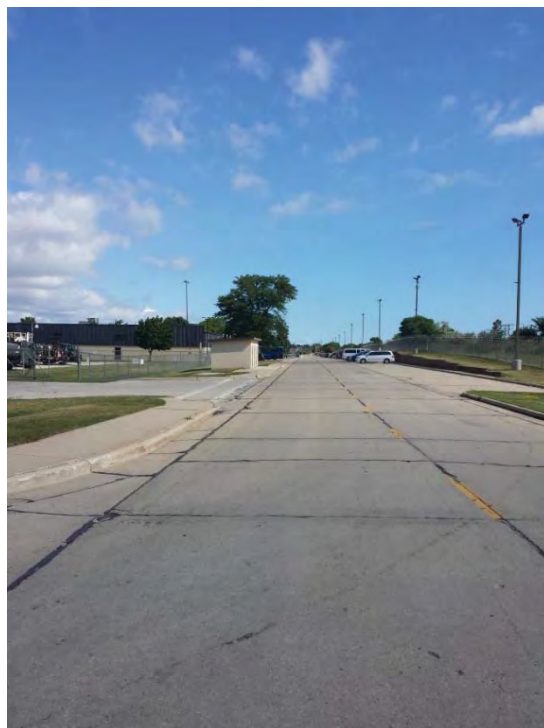
In the late 1990s, a truck fire occurred along the south end of Tanker Avenue. According to Base personnel, AFFF was used to extinguish the fire. There are no known records documenting emergency response or the amount of AFFF used. Any AFFF release in this area would have

been routed to the Base Drainage Ditch. There are no other truck fire instances where AFFF was used.

Photo 5: Looking north toward Truck Fire AOC.

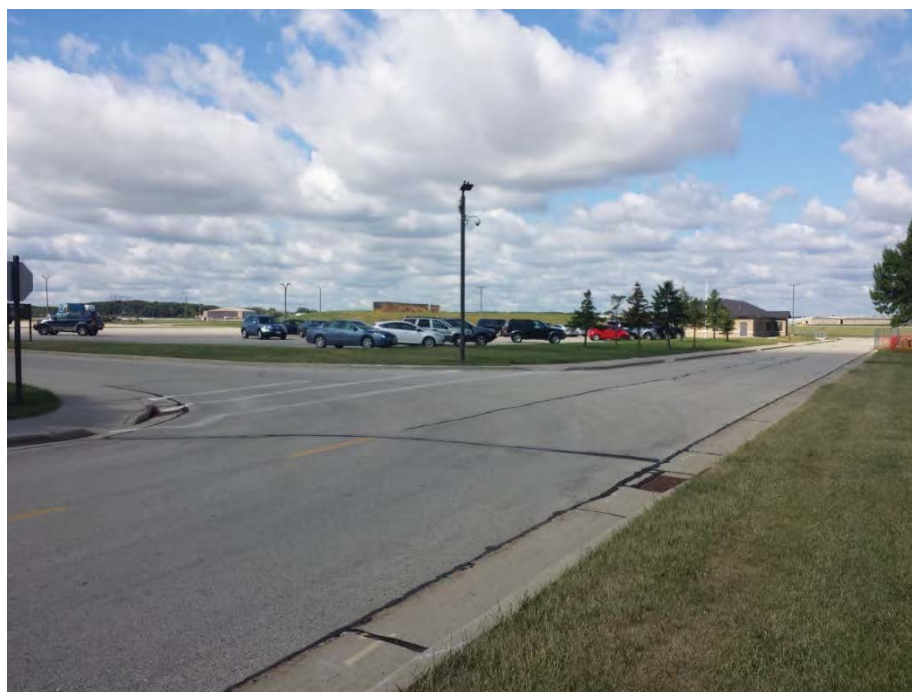
Although the exact start date of AFFF use is unknown, the WIANG FD used long stretches of road/grass in the southwest corner of Guard Central property for AFFF spray testing and calibration of vehicle equipment until August 6, 2015, when an order was received from ANG Headquarters to cease AFFF testing activities. Roads used for equipment testing included Prime Beef Drive, Performance Avenue, and Upset Avenue. Foam was observed in the Base Drainage Ditch during various equipment testing events. Following collection into the Base Drainage Ditch, any AFFF released may have been routed to Bailey's Pond, impacting surface water. AFFF released during equipment testing in porous green spaces may have seeped into the subsurface and groundwater.

Photo 6: Looking southeast toward the WIANG FD Equipment Testing Area along Prime Beef Drive at Guard Central.

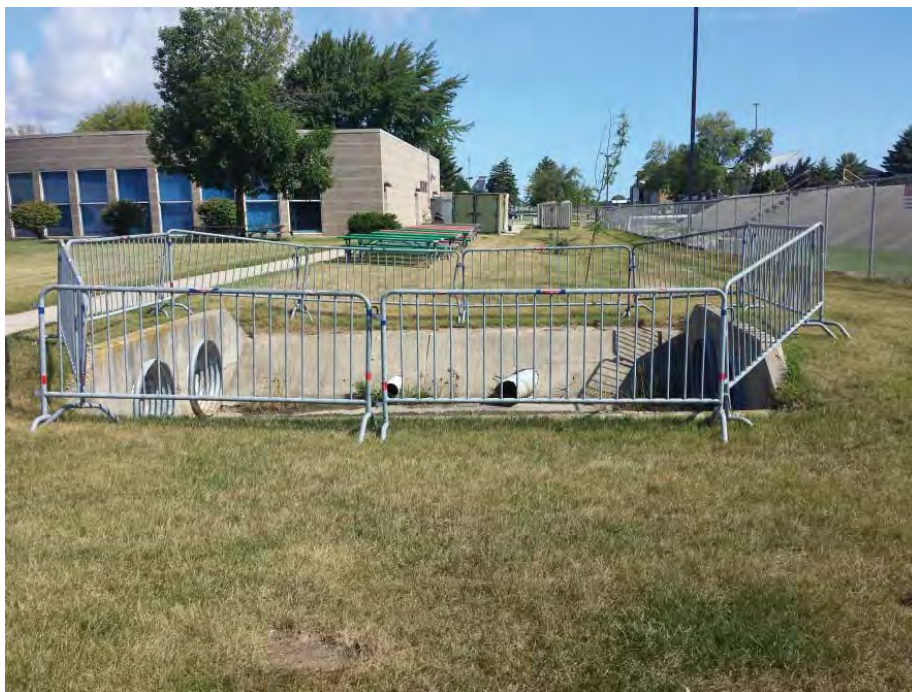
Photo 7: The southern portion of the Base drainage ditch at Guard Central.

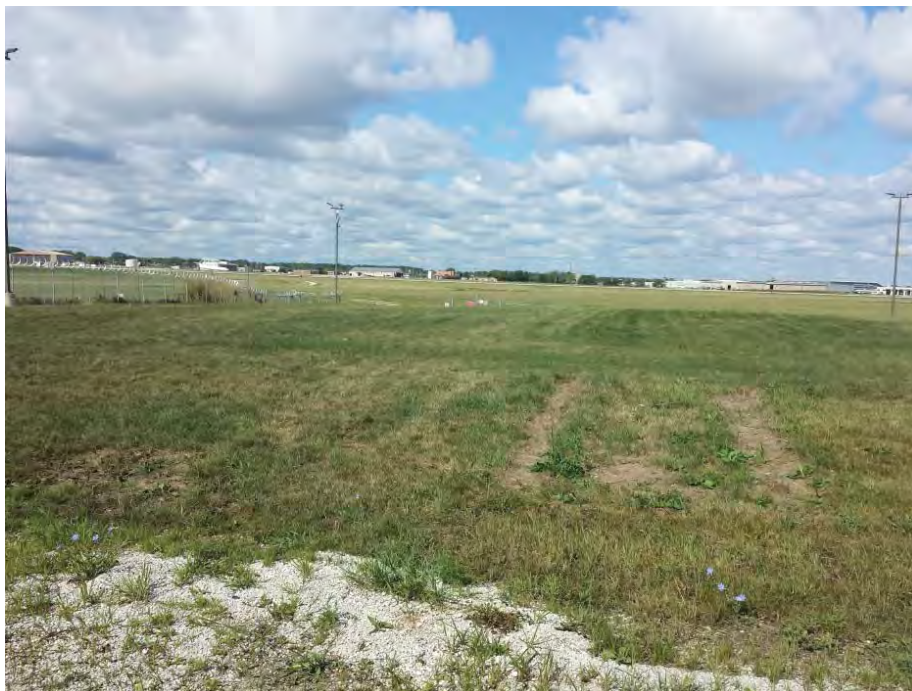
Photo 8: Looking west toward the WIANG FD Equipment Testing Area in the southeast corner of Guard Central.

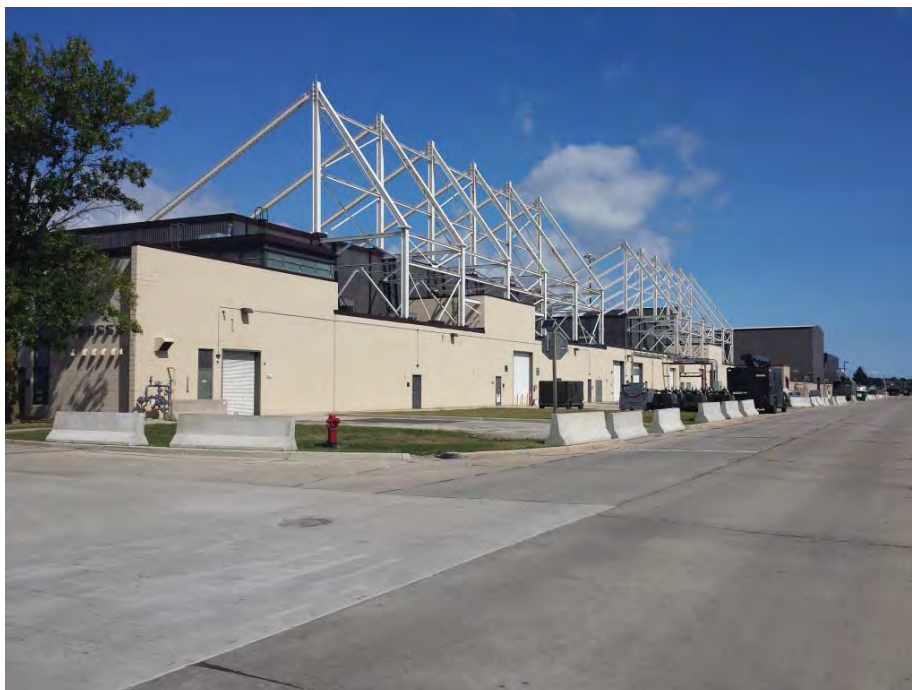
Photo 9: From left to right: Hangar 308, Hangar 306, Hangar 304 and Hangar 208.

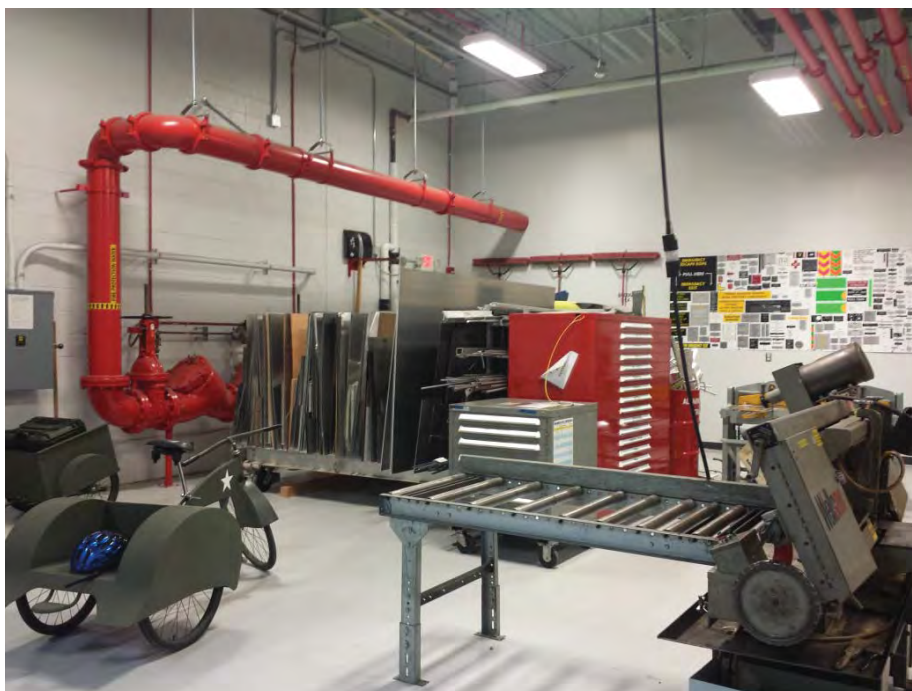
Photo 10: The former AFFF storage area at Hangar 306.

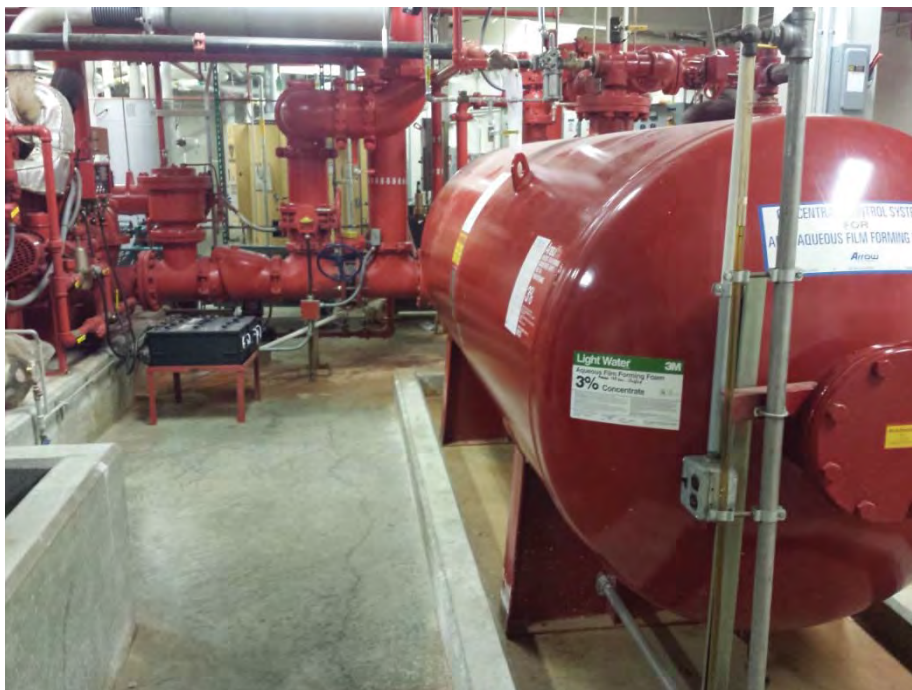
Hangar 208, located in the northeastern portion of Guard Central, has been equipped with AFFF fire suppression systems since the mid-1990s, and is currently using 3% 3M and/or Ansulite. According to WIANG personnel, hangar fire suppression systems are tested every third year or following extended down time (e.g., construction). Testing logs are included in Appendix C-6. No records of accidental foam releases exist; however, according to Mr. Culver during the PA site visit, there may have been an accidental release at Hangar 208 prior to his tenure, which began in 2004 (anecdotal knowledge). Any AFFF releases during testing or accidental release within the hangar would have been routed to the floor drains or trench drains, that lead to an oil/water separator (OWS) which then discharges into the sanitary sewer system.

Photo 11: The AFFF fire suppression system at Hangar 208

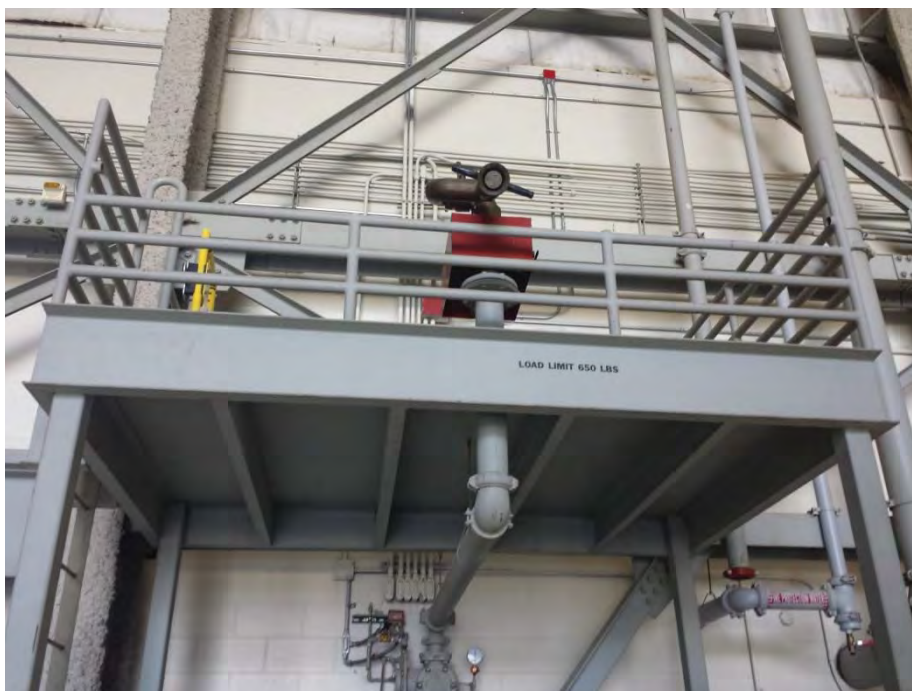
Photo 12: One of four AFFF cannons inside Hangar 208.

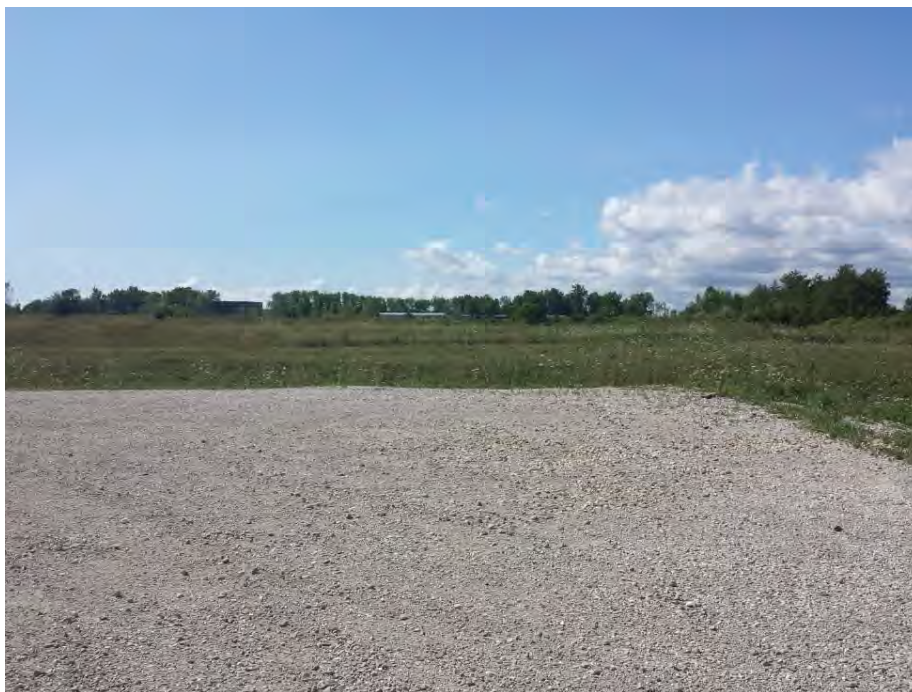
According to Base personnel, the WIANG FD may have used the property parcel south of Grange Avenue (Guard East) for AFFF spray testing and calibration of vehicle equipment. Surface water in this area typically flows into the drainage ditches along Grange Avenue, which discharge into Bailey's Pond (BEM, 2009). Any AFFF released in porous green spaces has the potential to seep into the subsurface and groundwater.

Photo 13: Looking south toward the potential WIANG FD Equipment Testing Area at Guard East.

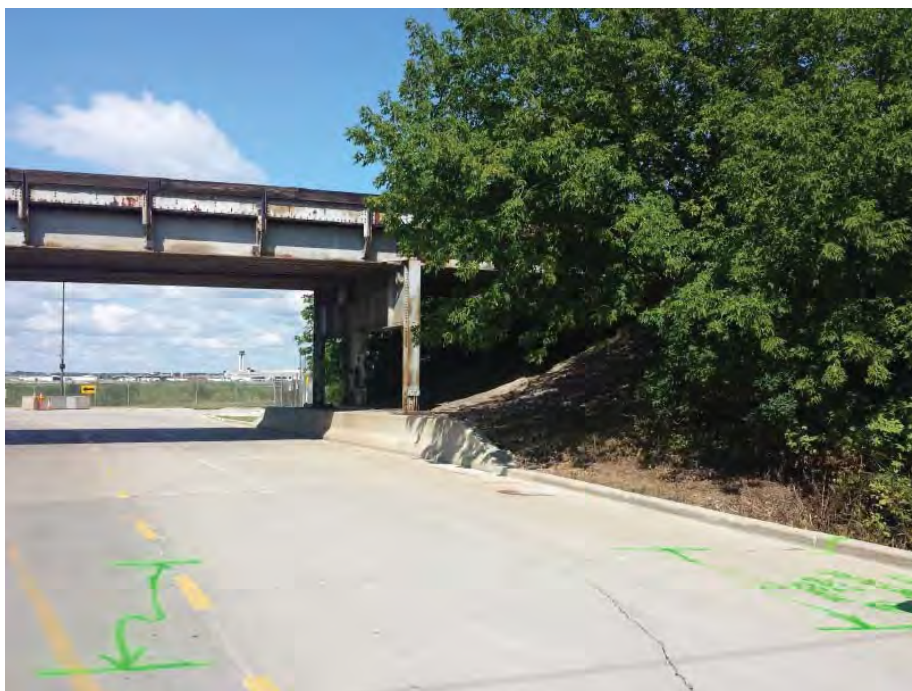
Photo 14: An artesian well exists to the right of the train trestle.

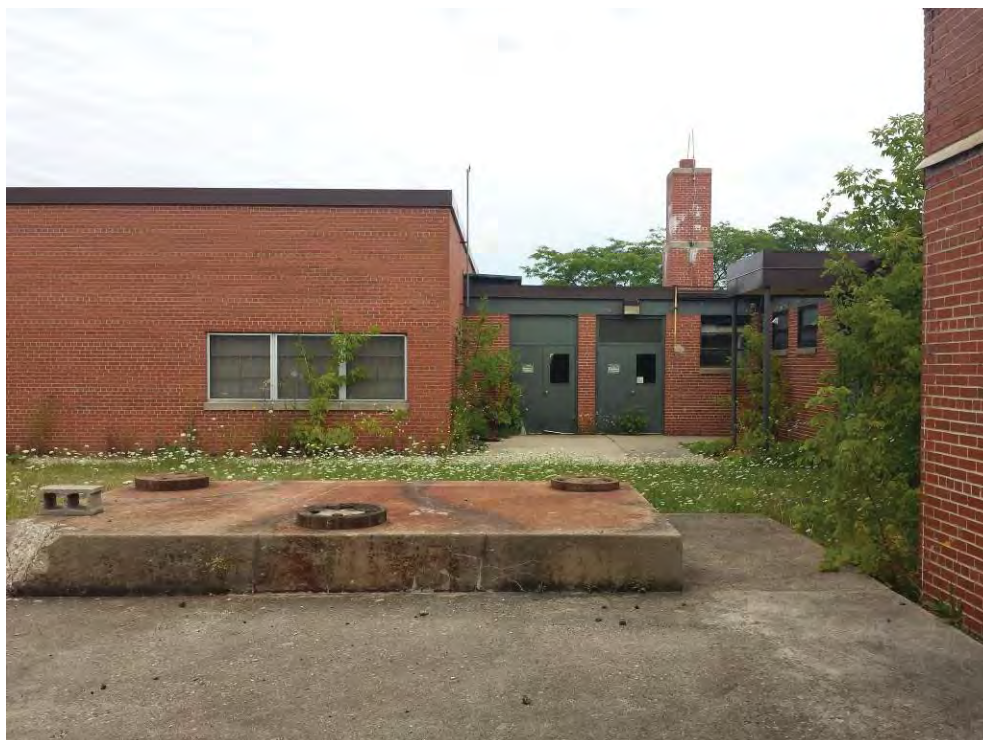
Photo 15: A potable water well is located inside the left door at Building 301 at Guard West.

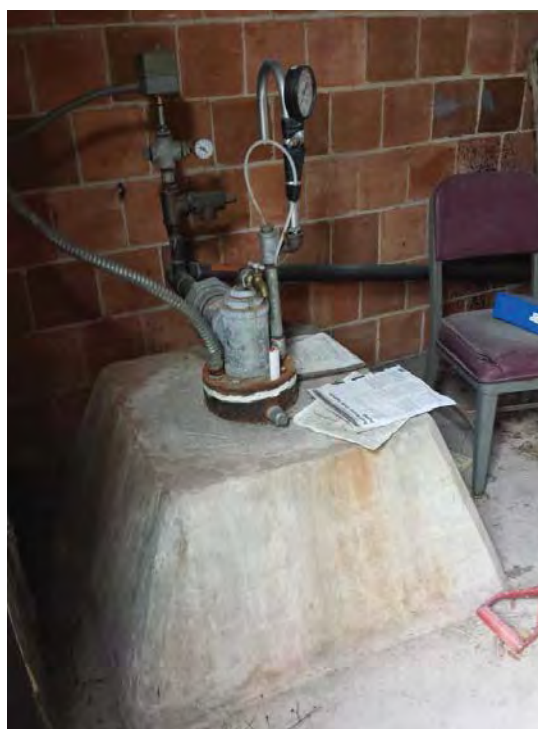
Photo 16: The Guard West potable water well, located inside Building 301.

No.	Potential AFFF PFC AOCs	GPS Coordinates		Rationale	Recommendation
		Latitude	Longitude		
18	Guard West Potable Water Well	42.938181°	-87.901347°	Dependent upon groundwater direction, may have been impacted by potential AFFF activities at the WIANF FD Equipment Testing Area (Guard South) AOC	Proceed to SI; focus on groundwater.
19	Guard East Artesian Well	42.944691°	-87.884938°	May have been impacted by the WIANF FD Equipment Testing Area (Guard East) AOC	Proceed to SI; focus on groundwater.

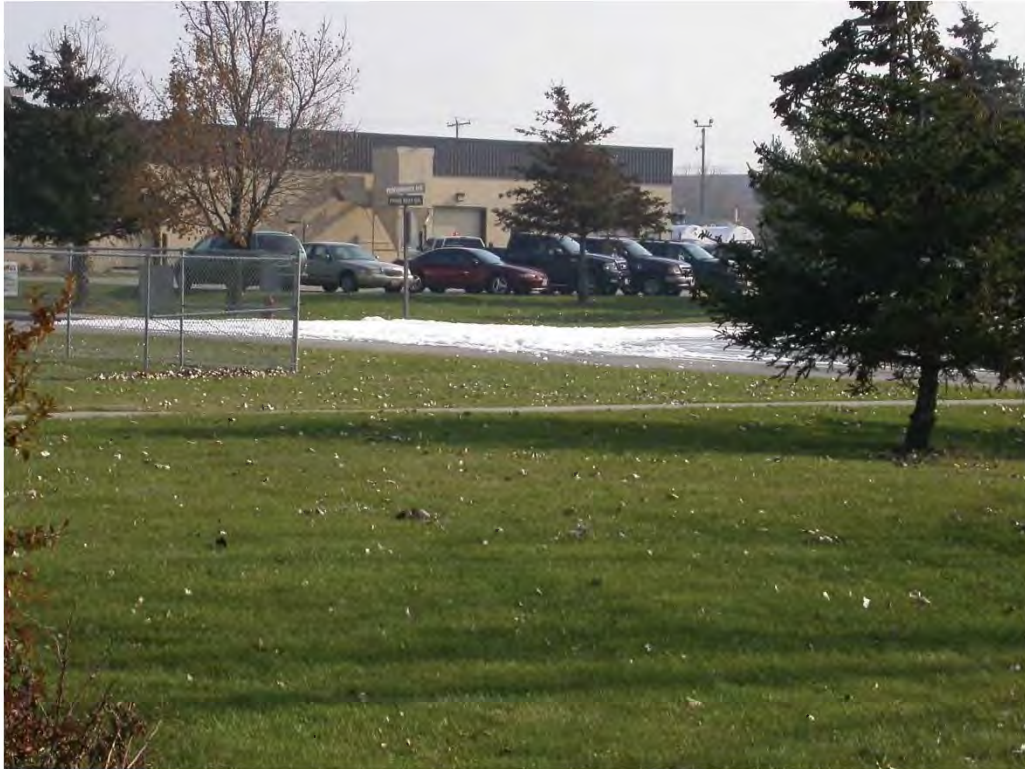
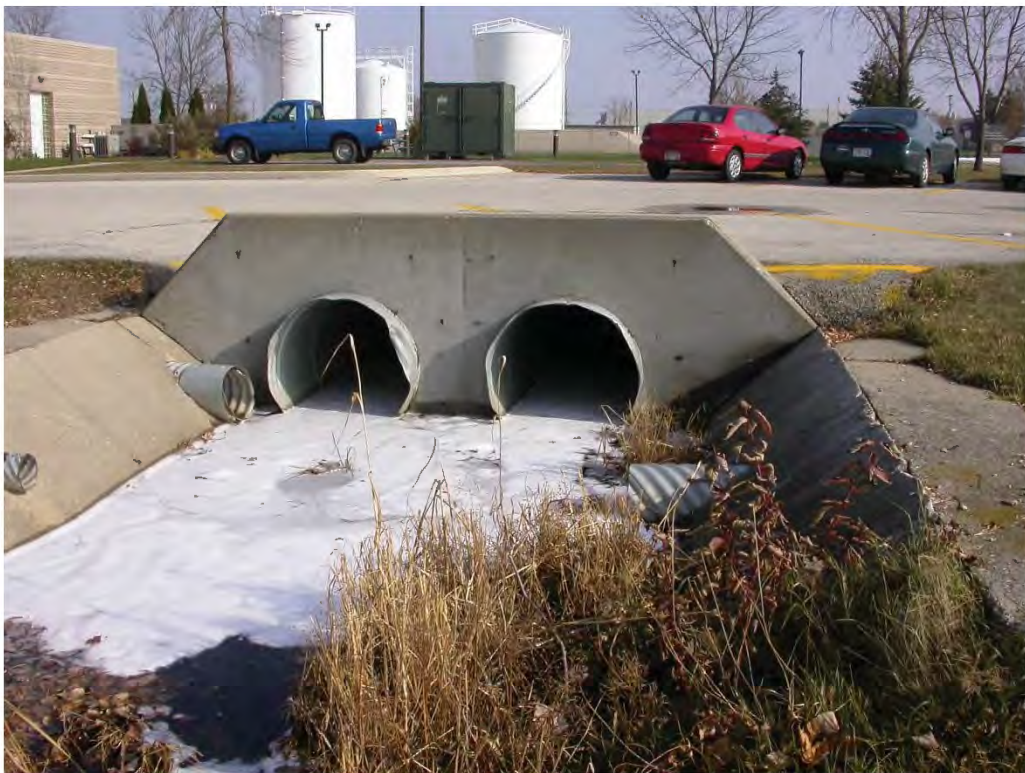
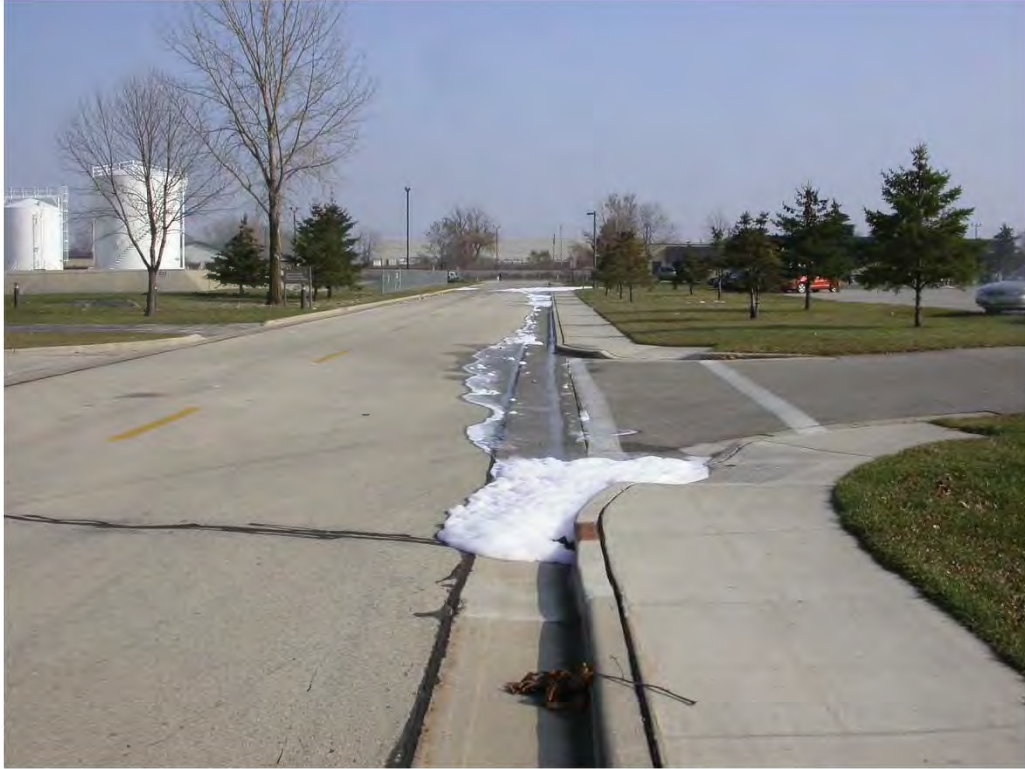
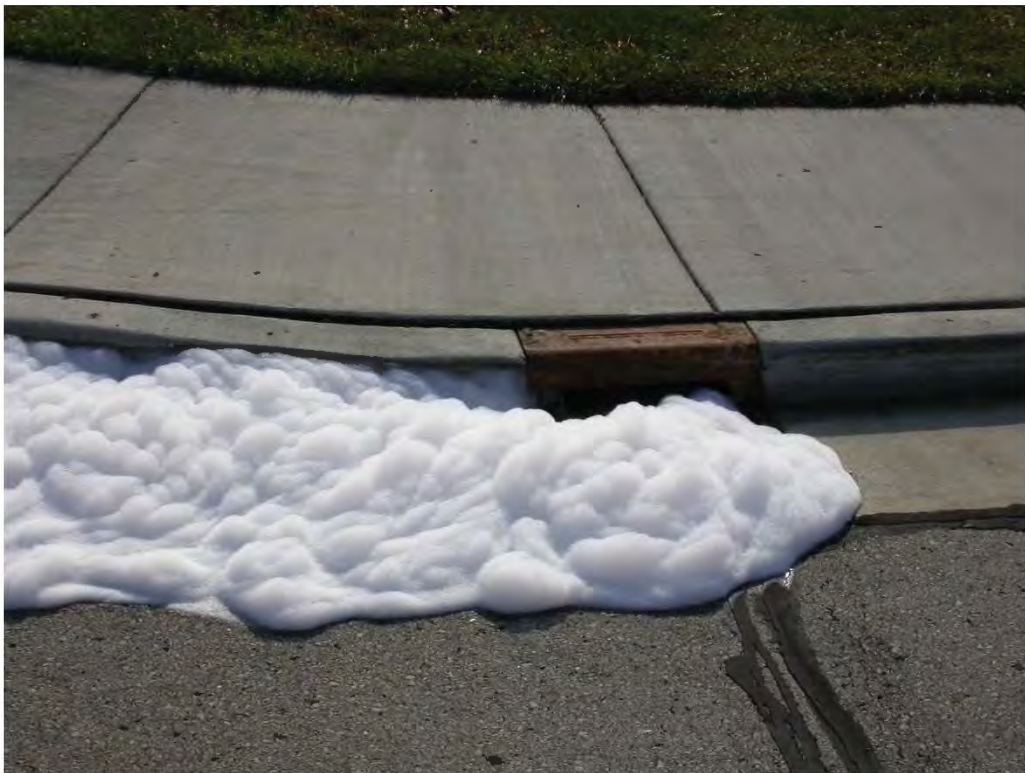
**BASE PHOTO DOCUMENTATION OF AFFF RELEASES (GUARD CENTRAL) –
CIRCA 2000s**

Appendix C-5 includes photographs from Base personnel showing AFFF releases from FD equipment testing.
