CALENDAR YEAR 2018 LONG-TERM MONITORING/ LONG-TERM OPERATIONS REPORT

HOLSTON ARMY AMMUNITION PLANT

KINGSPORT, TENNESSEE

**Calendar Year 2018 Long-Term Monitoring/Long-Term Operations Report for
Holston Army Ammunition Plant, Kingsport, Tennessee, EPA ID No. TN521-002-0421
March 2019**

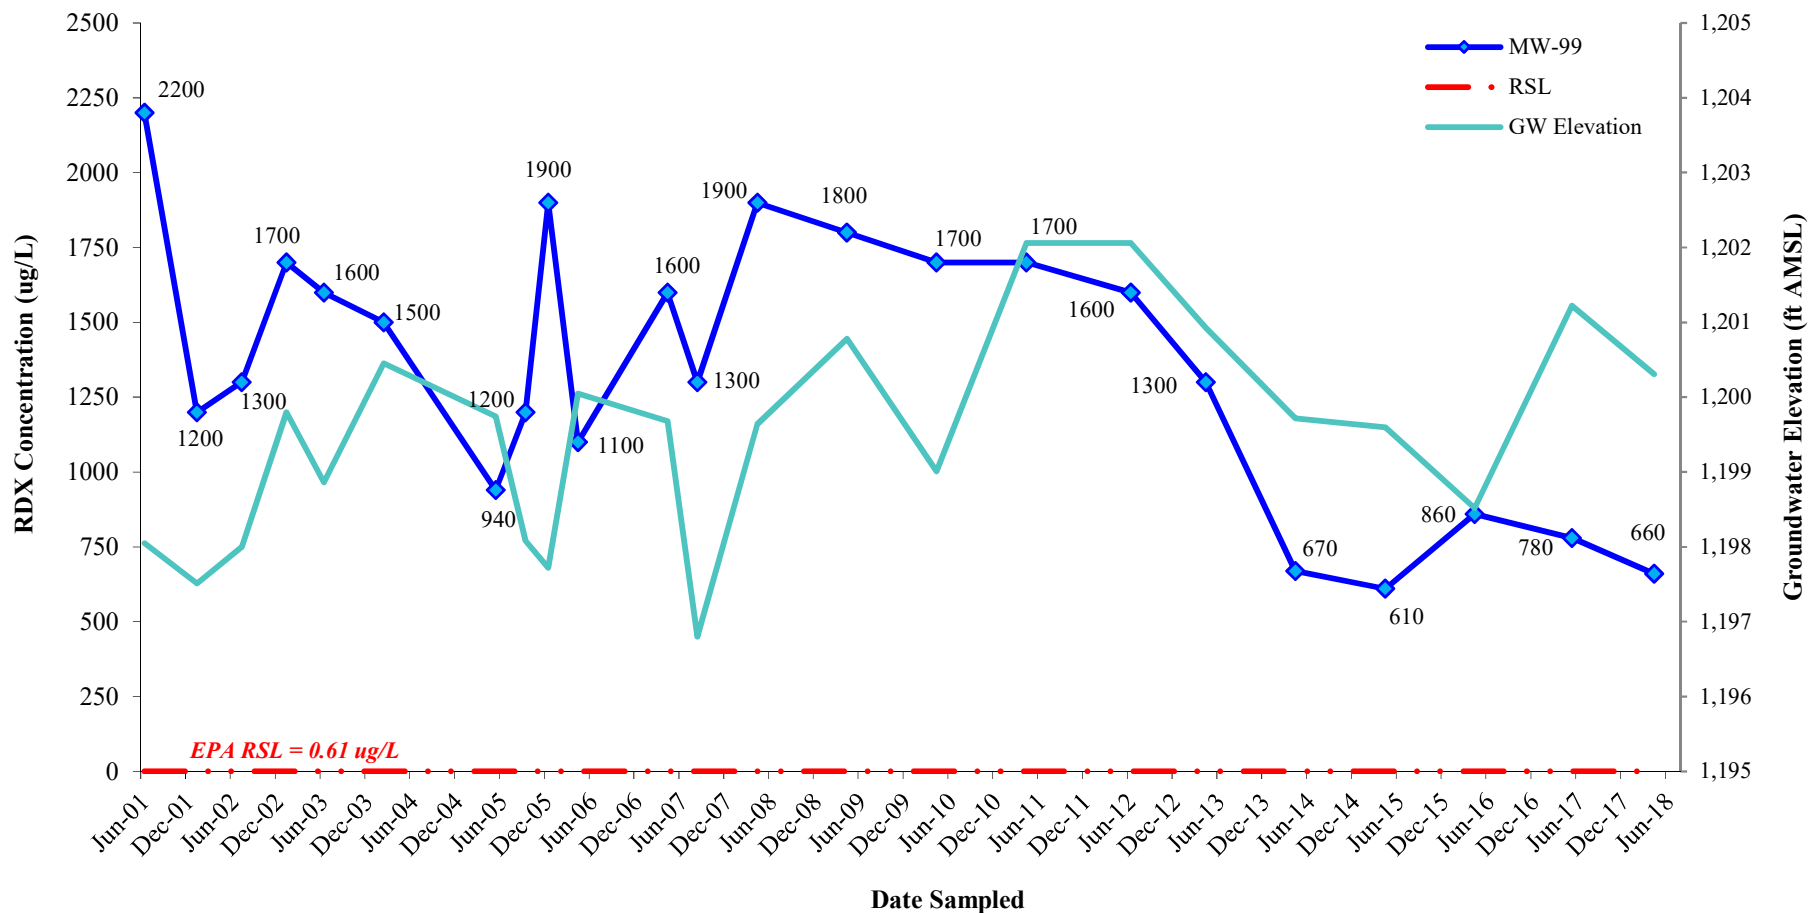
Figure 4-8. RDX Concentration Trend in MW-99 in the Explosives Production Area, 2001 – 2018

Groundwater well MW-99 within the explosives production area was sampled in spring 2018 for CAO-listed target analytes (2,4-DNT; 2,6-DNT; 2,4,6-TNT; 2-amino-4,6-DNT; 4-amino-2,6-DNT; nitroglycerin; and RDX) and RDX first-stage degradation products (DNX, MNX, and TNX) (Table 4-6). The distribution of current and historical RDX detections in Area B is presented on Figure 4-7. RDX was the only target analyte to exceed its RSL of 0.61 µg/L (660 µg/L).

Note: The September 2006 result is suspect; data are from a Sample Data Group with multiple results that are outliers compared to historical data. As a result, the September 2006 data were removed from the trend graph. The September 2005, April 2006, and April 2018 values are based on the sample duplicates, which had higher concentrations than the main samples
