June 20, 2012

RE: Petition for Assessment of Asbestos Exposure Pathways at Badger AAP

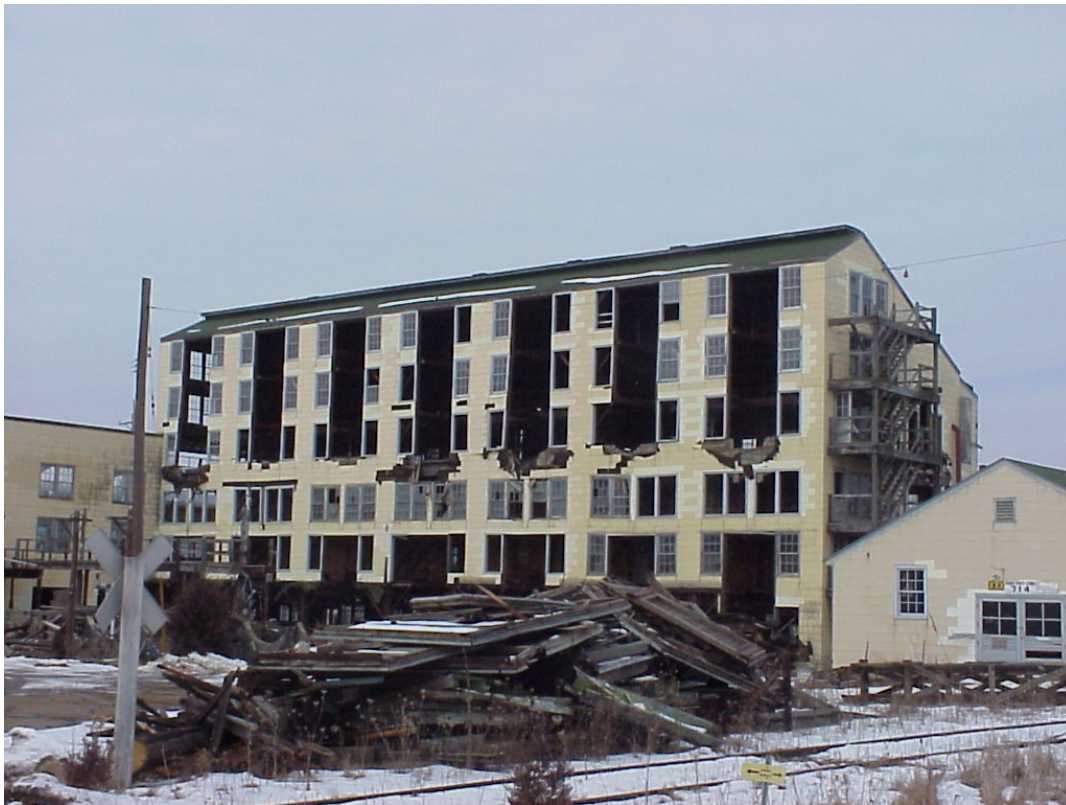
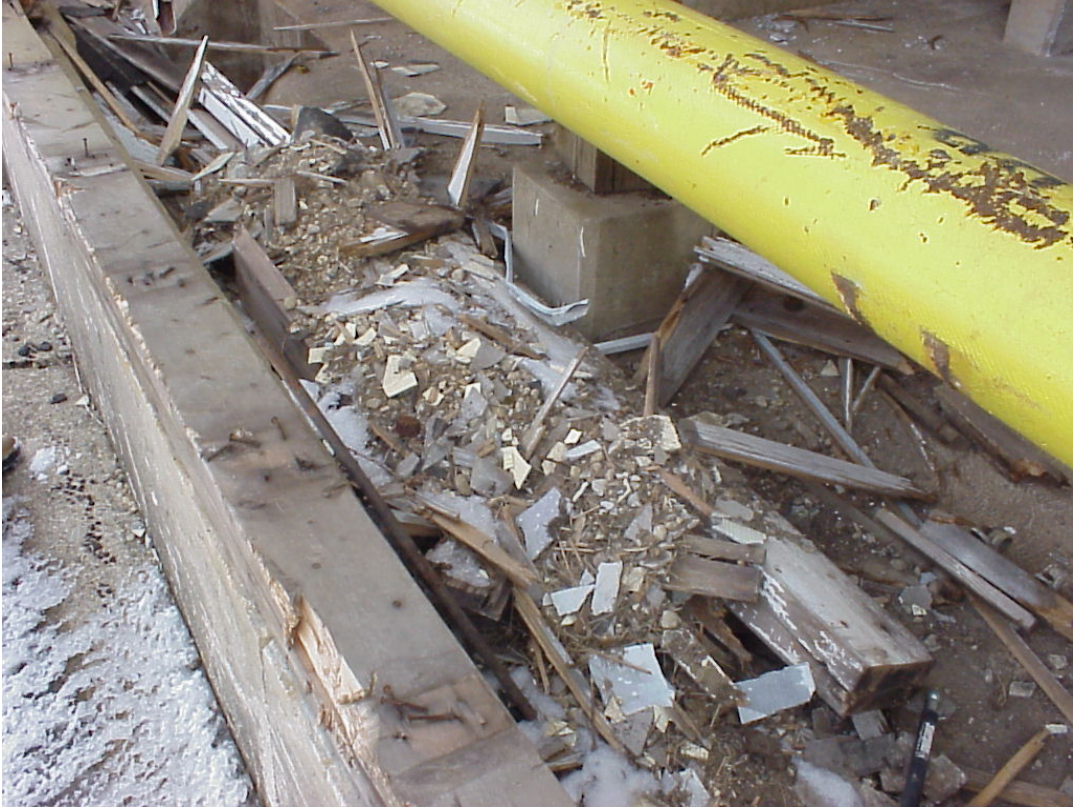
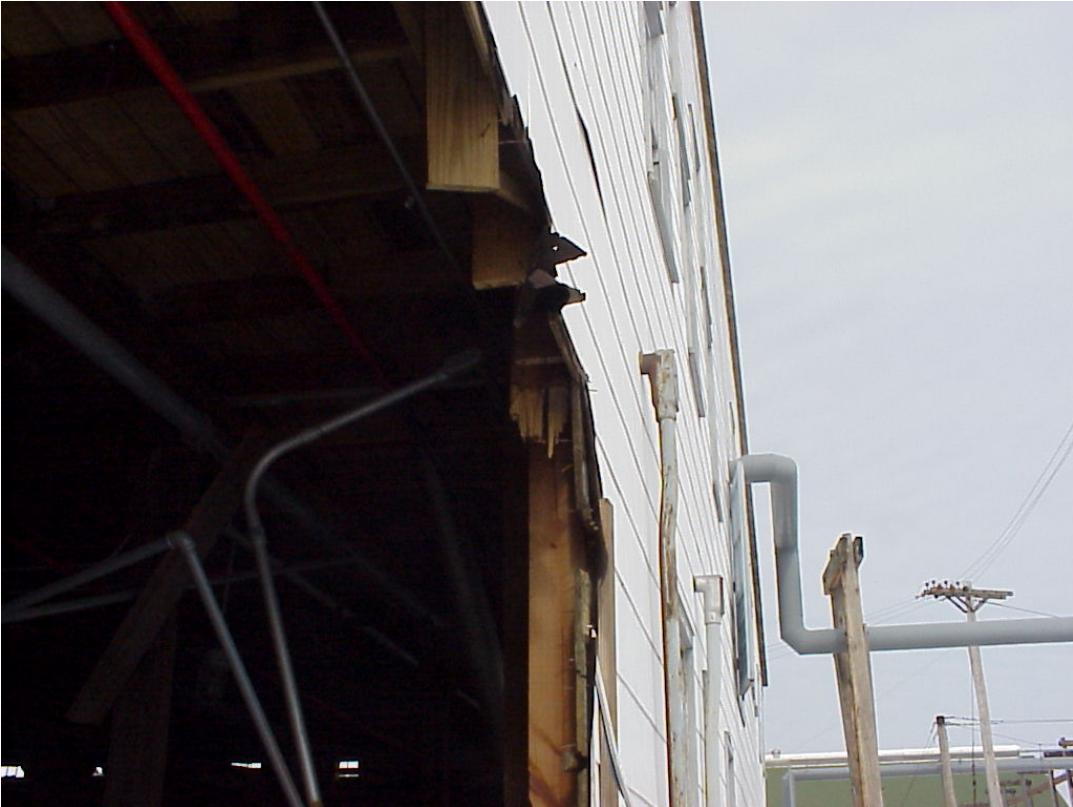
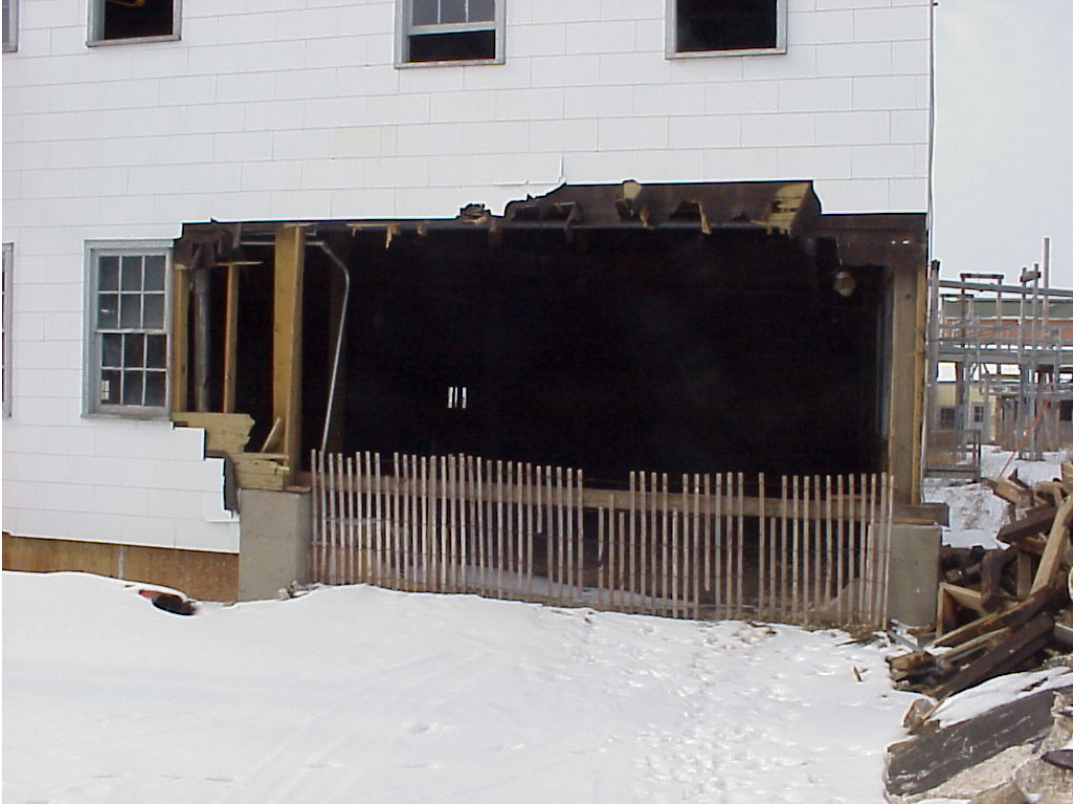
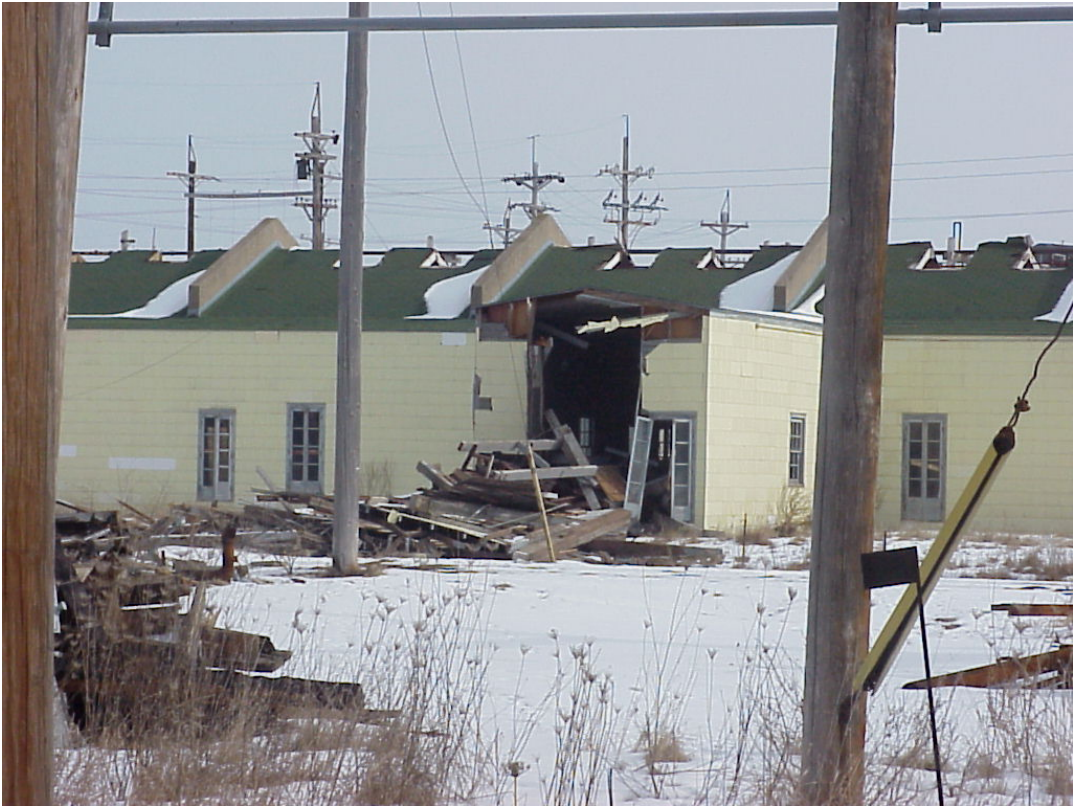
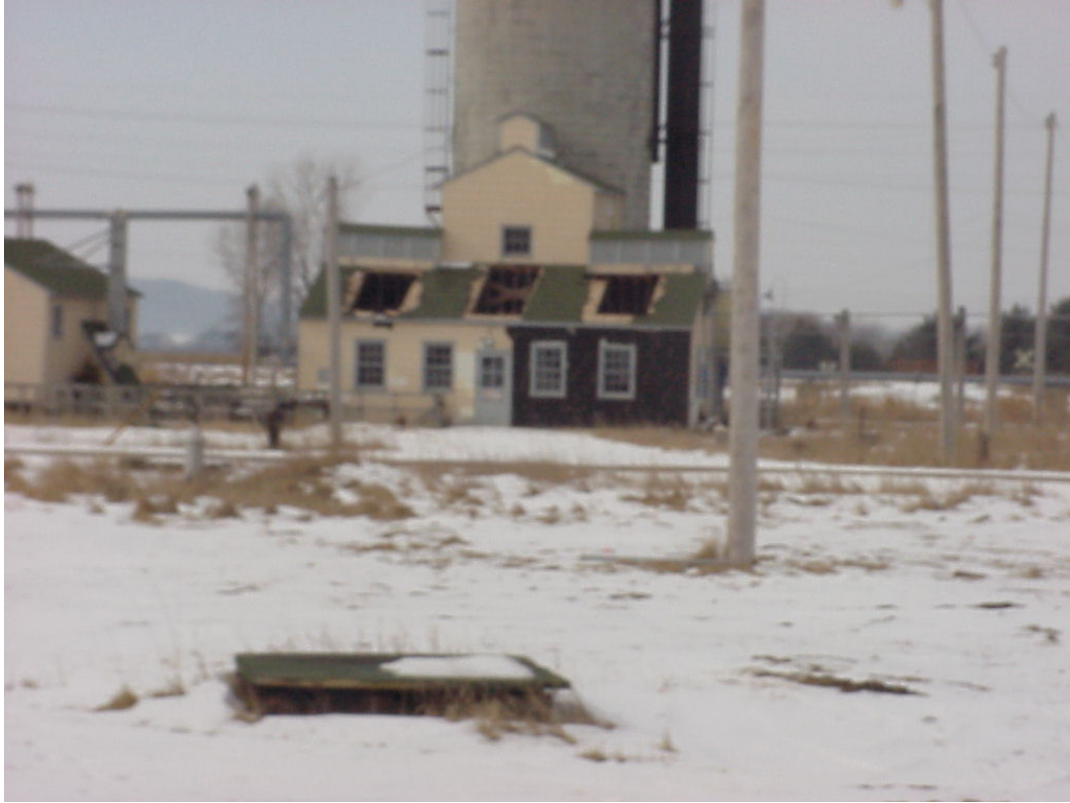
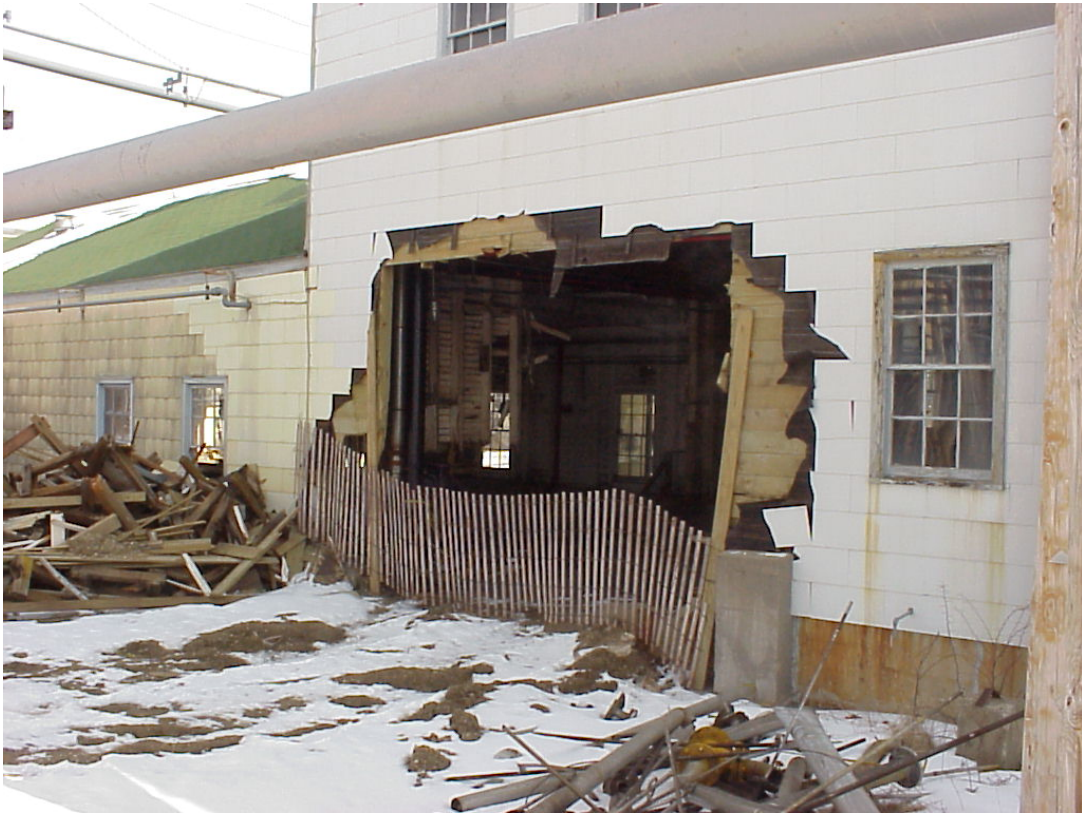
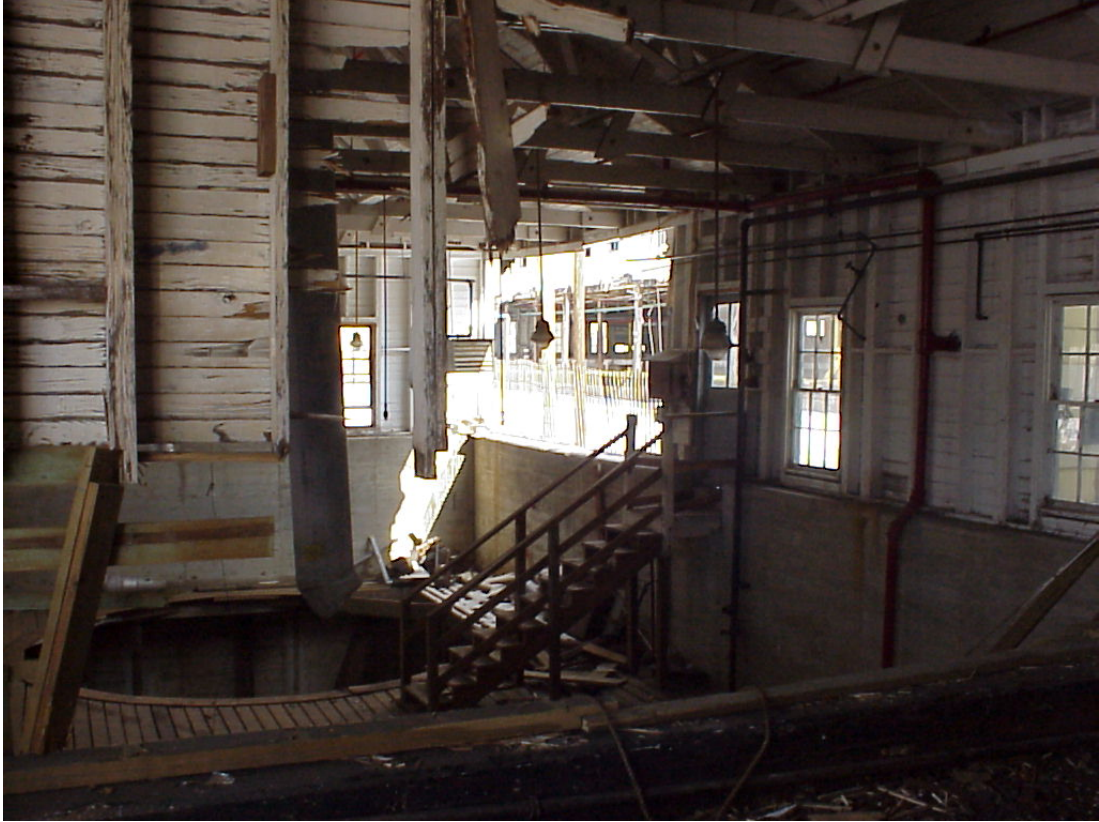
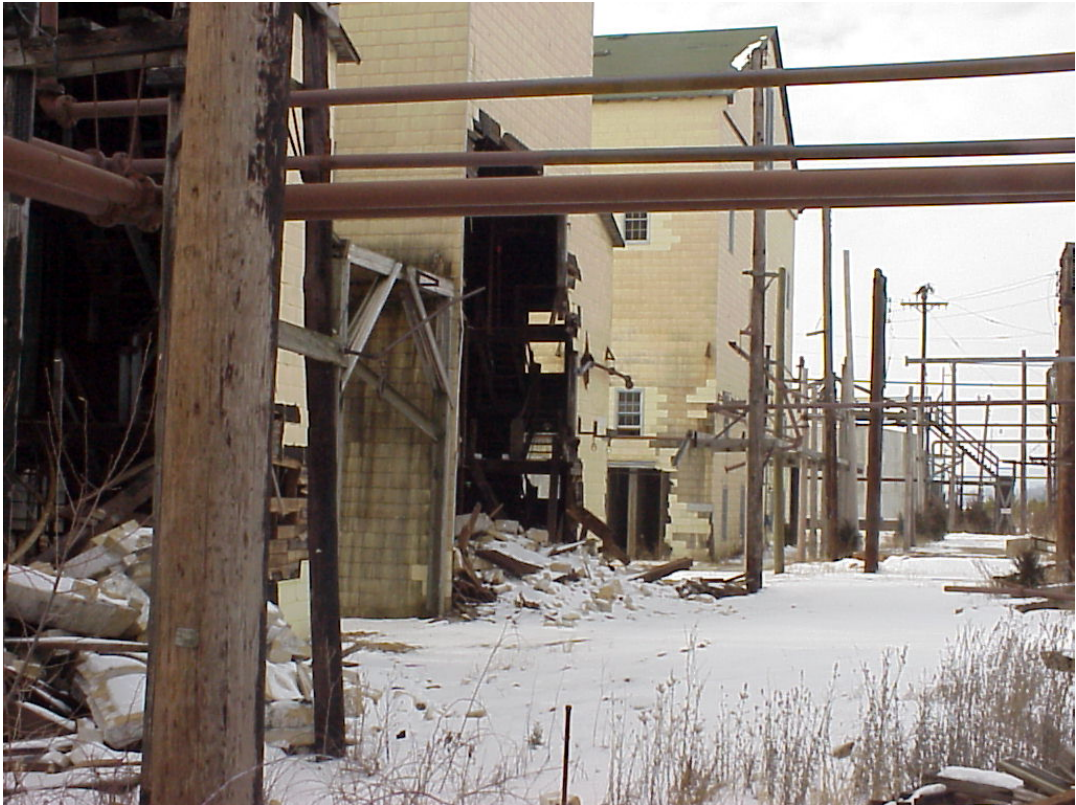
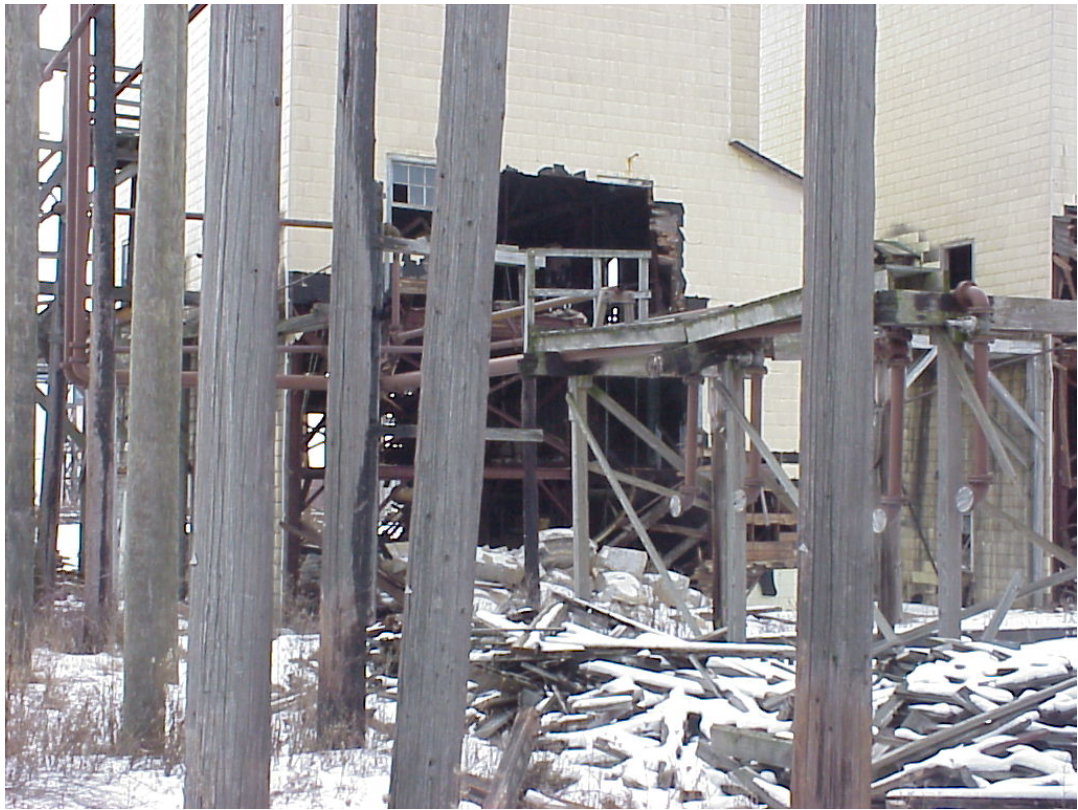
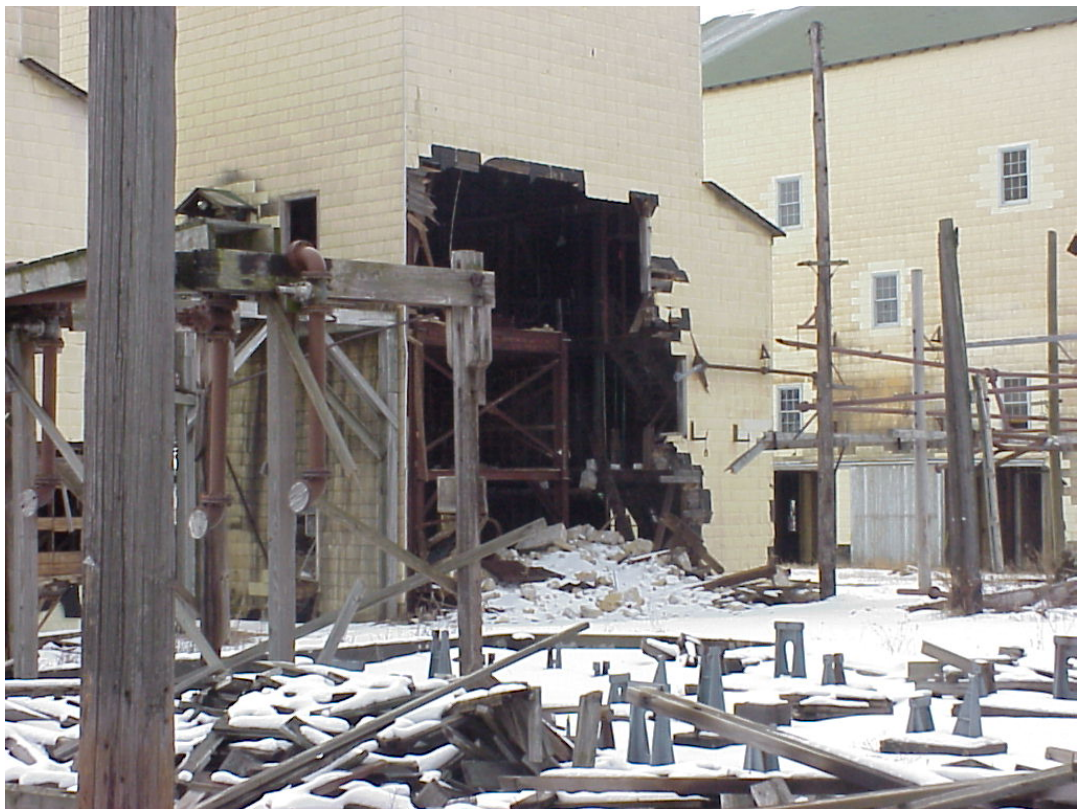
Attached: Photographs of partially demolished buildings at Badger Army Ammunition Plant with significant disturbance of asbestos-containing materials (2005).
