**Site Management Plan
Fiscal Year 2018**

**Atlantic Fleet Weapons Training Area – Vieques
Vieques, Puerto Rico**

**CH2M HILL, Inc.
Virginia Beach, Virginia**

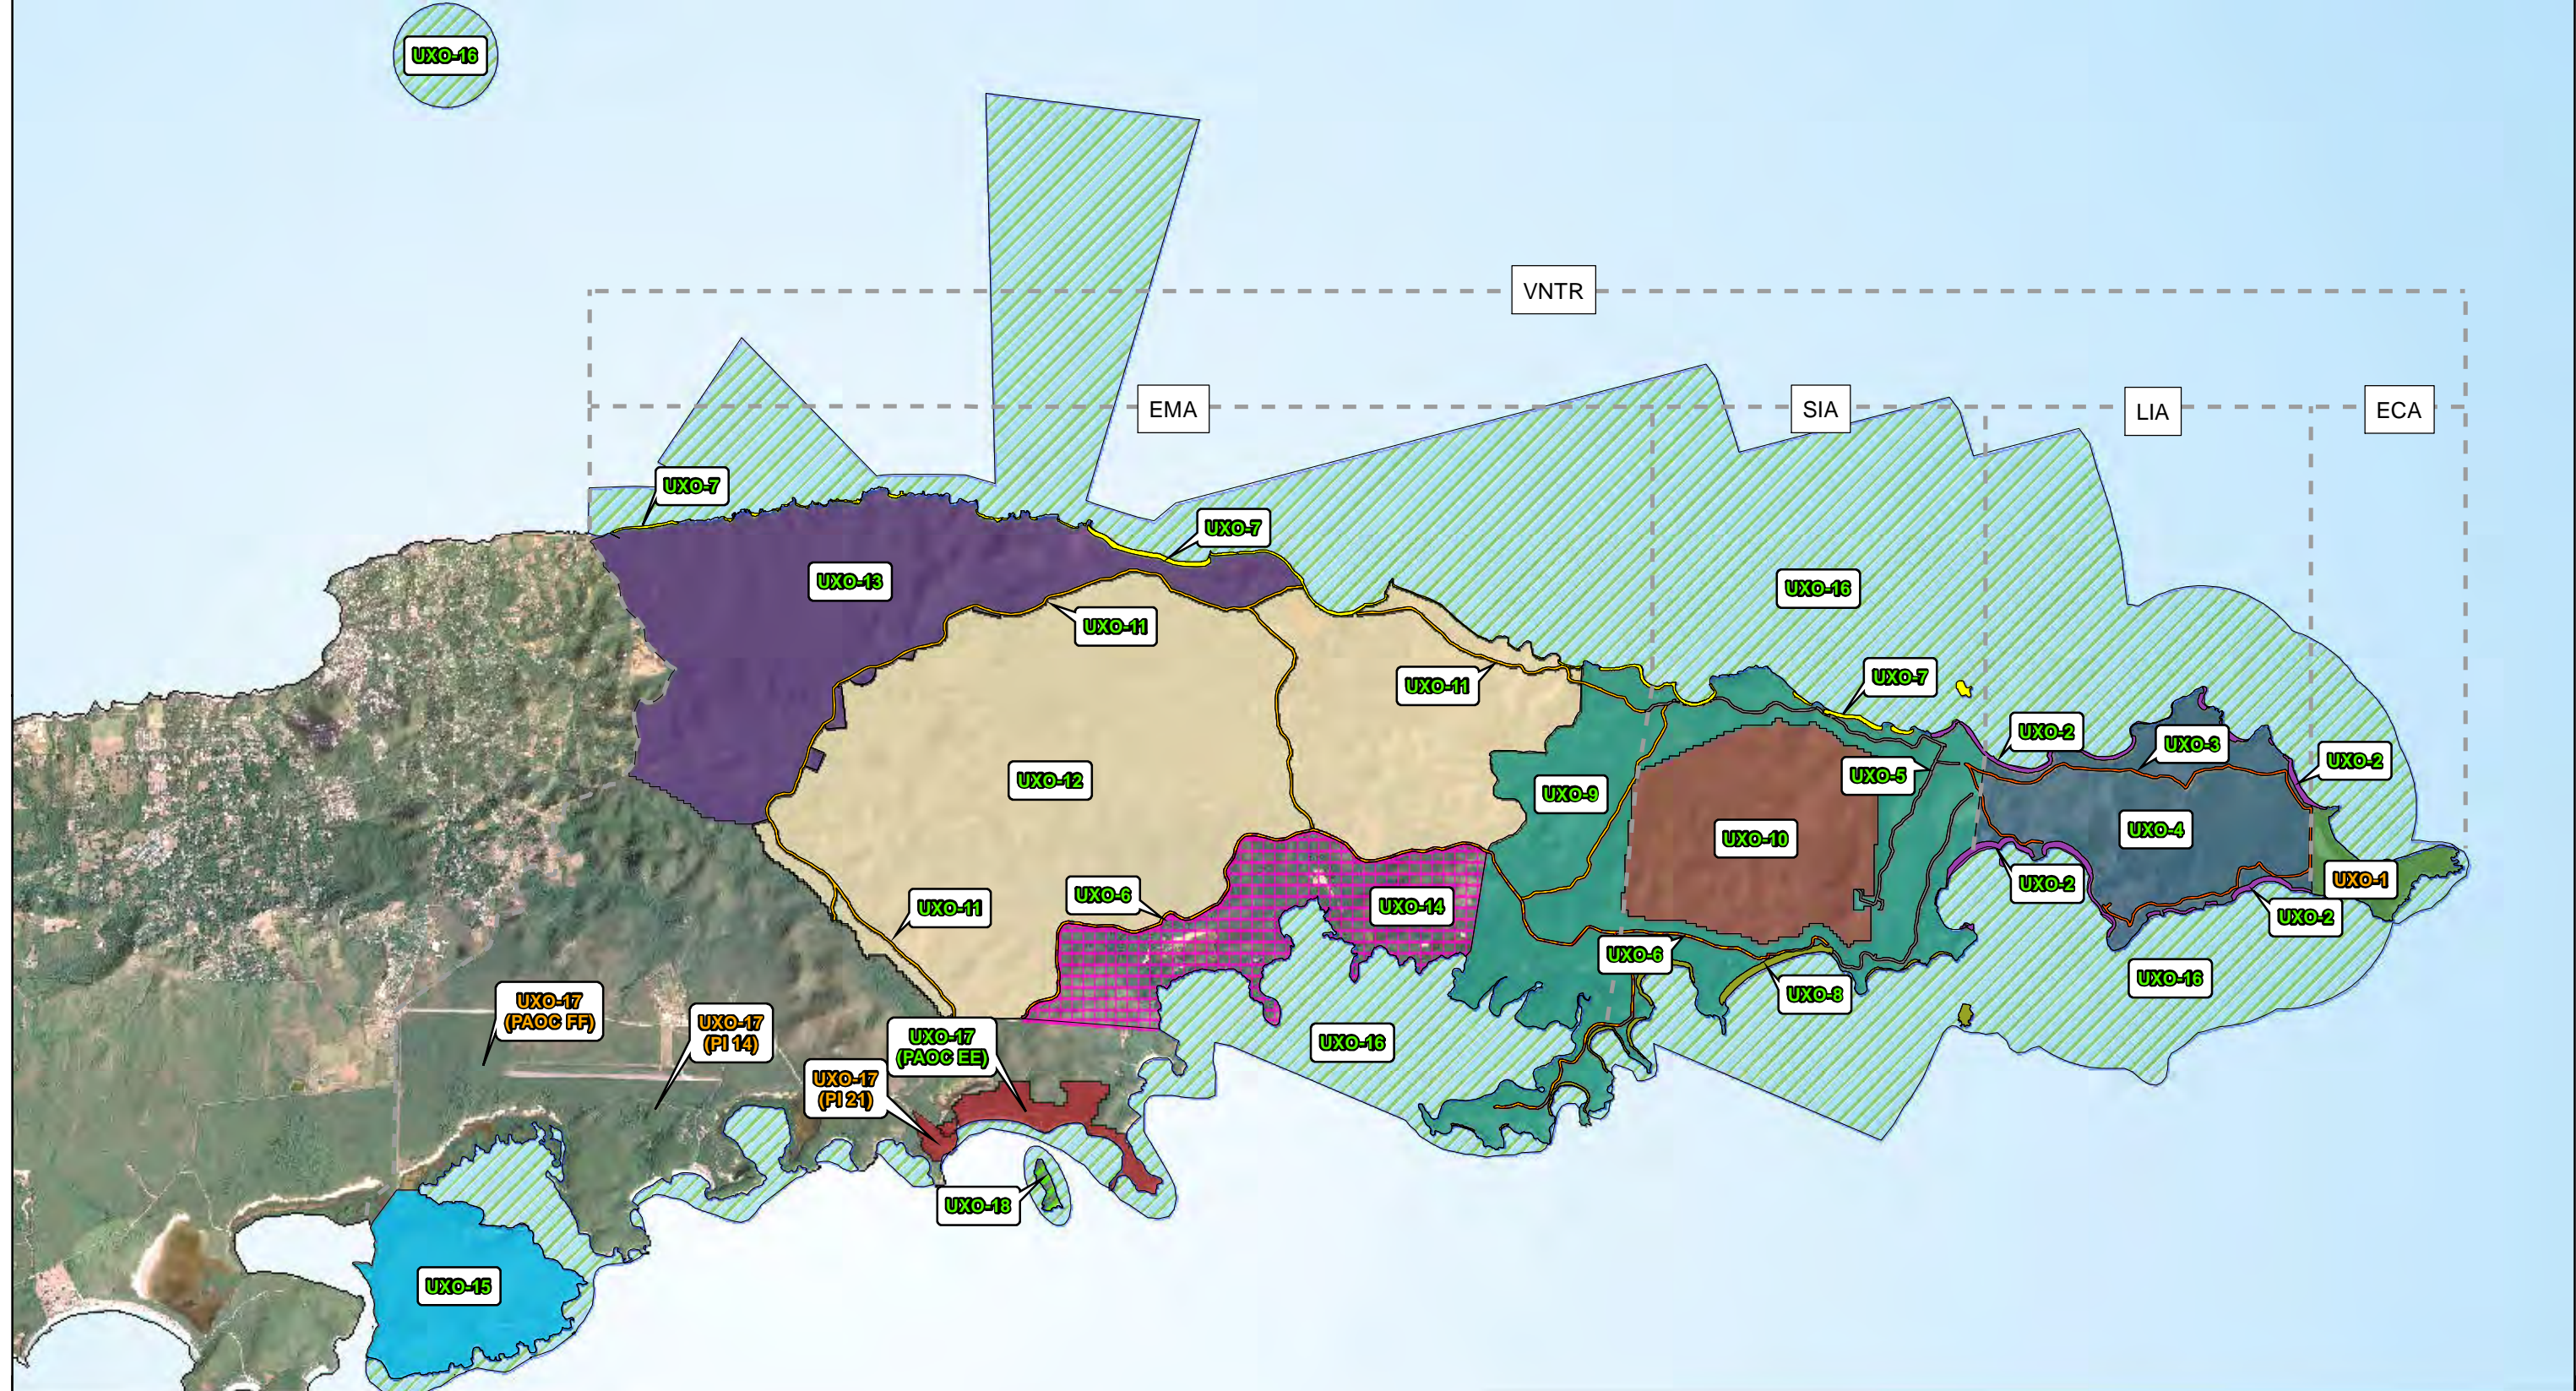
Figure 2-2
East Vieques Munitions Response Sites
Site Management Plan, FY 2018
Vieques, Puerto Rico

- Legend**
- Munitions Response Sites**
- UXO 1 - ECA
 - UXO 2 - LIA Beaches
 - UXO 3 - LIA Roads
 - UXO 4 - LIA Interior
 - UXO 5 - SIA Restricted Roads
 - UXO 6 - EMA/SIA Public Roads
 - UXO 7 - EMA/SIA North Beaches
 - UXO 8 - SIA South Beaches
 - UXO 9 - SIA Exterior
 - UXO 10 - SIA Interior
 - UXO 11 - EMA Public Roads
 - UXO 12 - EMA Interior
 - UXO 13 - EMA West
 - UXO 14 - EMA South
 - UXO 15 - Puerto Ferro
 - UXO 16 - Underwater Areas
 - UXO 17 - Camp Garcia Area (PAOC EE, PAOC FF, PI 14 and PI 21)
 - UXO 18 - Cayo de la Chiva

The following updates the munitions response sites' status. For the purpose of this SMP, the number of munitions and explosives of concern (MEC) listed includes unexploded ordnance (UXO) and discarded military munitions (DMM) and material potentially presenting an explosive hazard (MPPEH) and does not include MD. The locations of the eastern Vieques munitions response sites are shown in **Figure 2-2**.

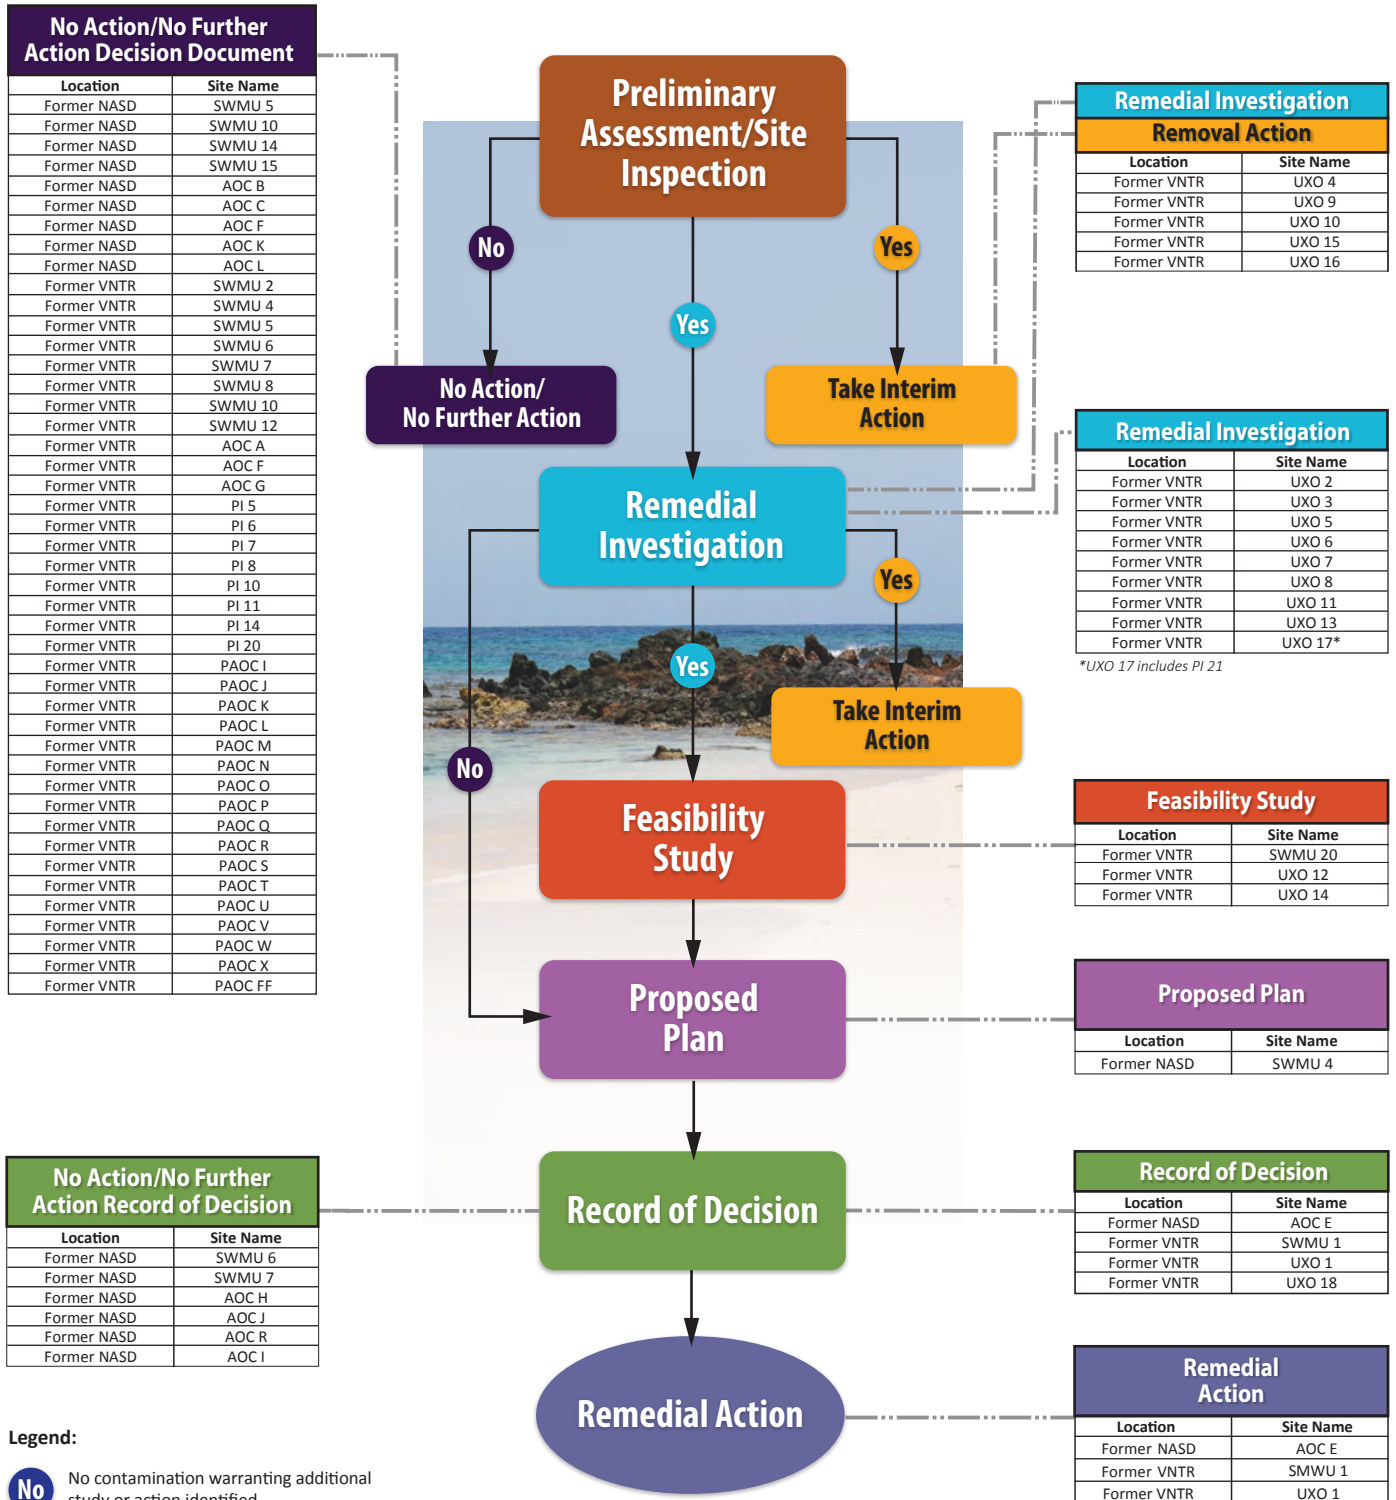
Figure 2-4
Status of Vieques Cleanup Program Sites Under CERCLA
Site Management Plan, FY 2018
Vieques, Puerto Rico

73 total sites — 51 sites (70%) completed with no further action as of October 2017
