CALENDAR YEAR 2018 LONG-TERM MONITORING/ LONG-TERM OPERATIONS REPORT

HOLSTON ARMY AMMUNITION PLANT

KINGSPORT, TENNESSEE

**Calendar Year 2018 Long-Term Monitoring/Long-Term Operations Report for
Holston Army Ammunition Plant, Kingsport, Tennessee, EPA ID No. TN521-002-0421
March 2019**

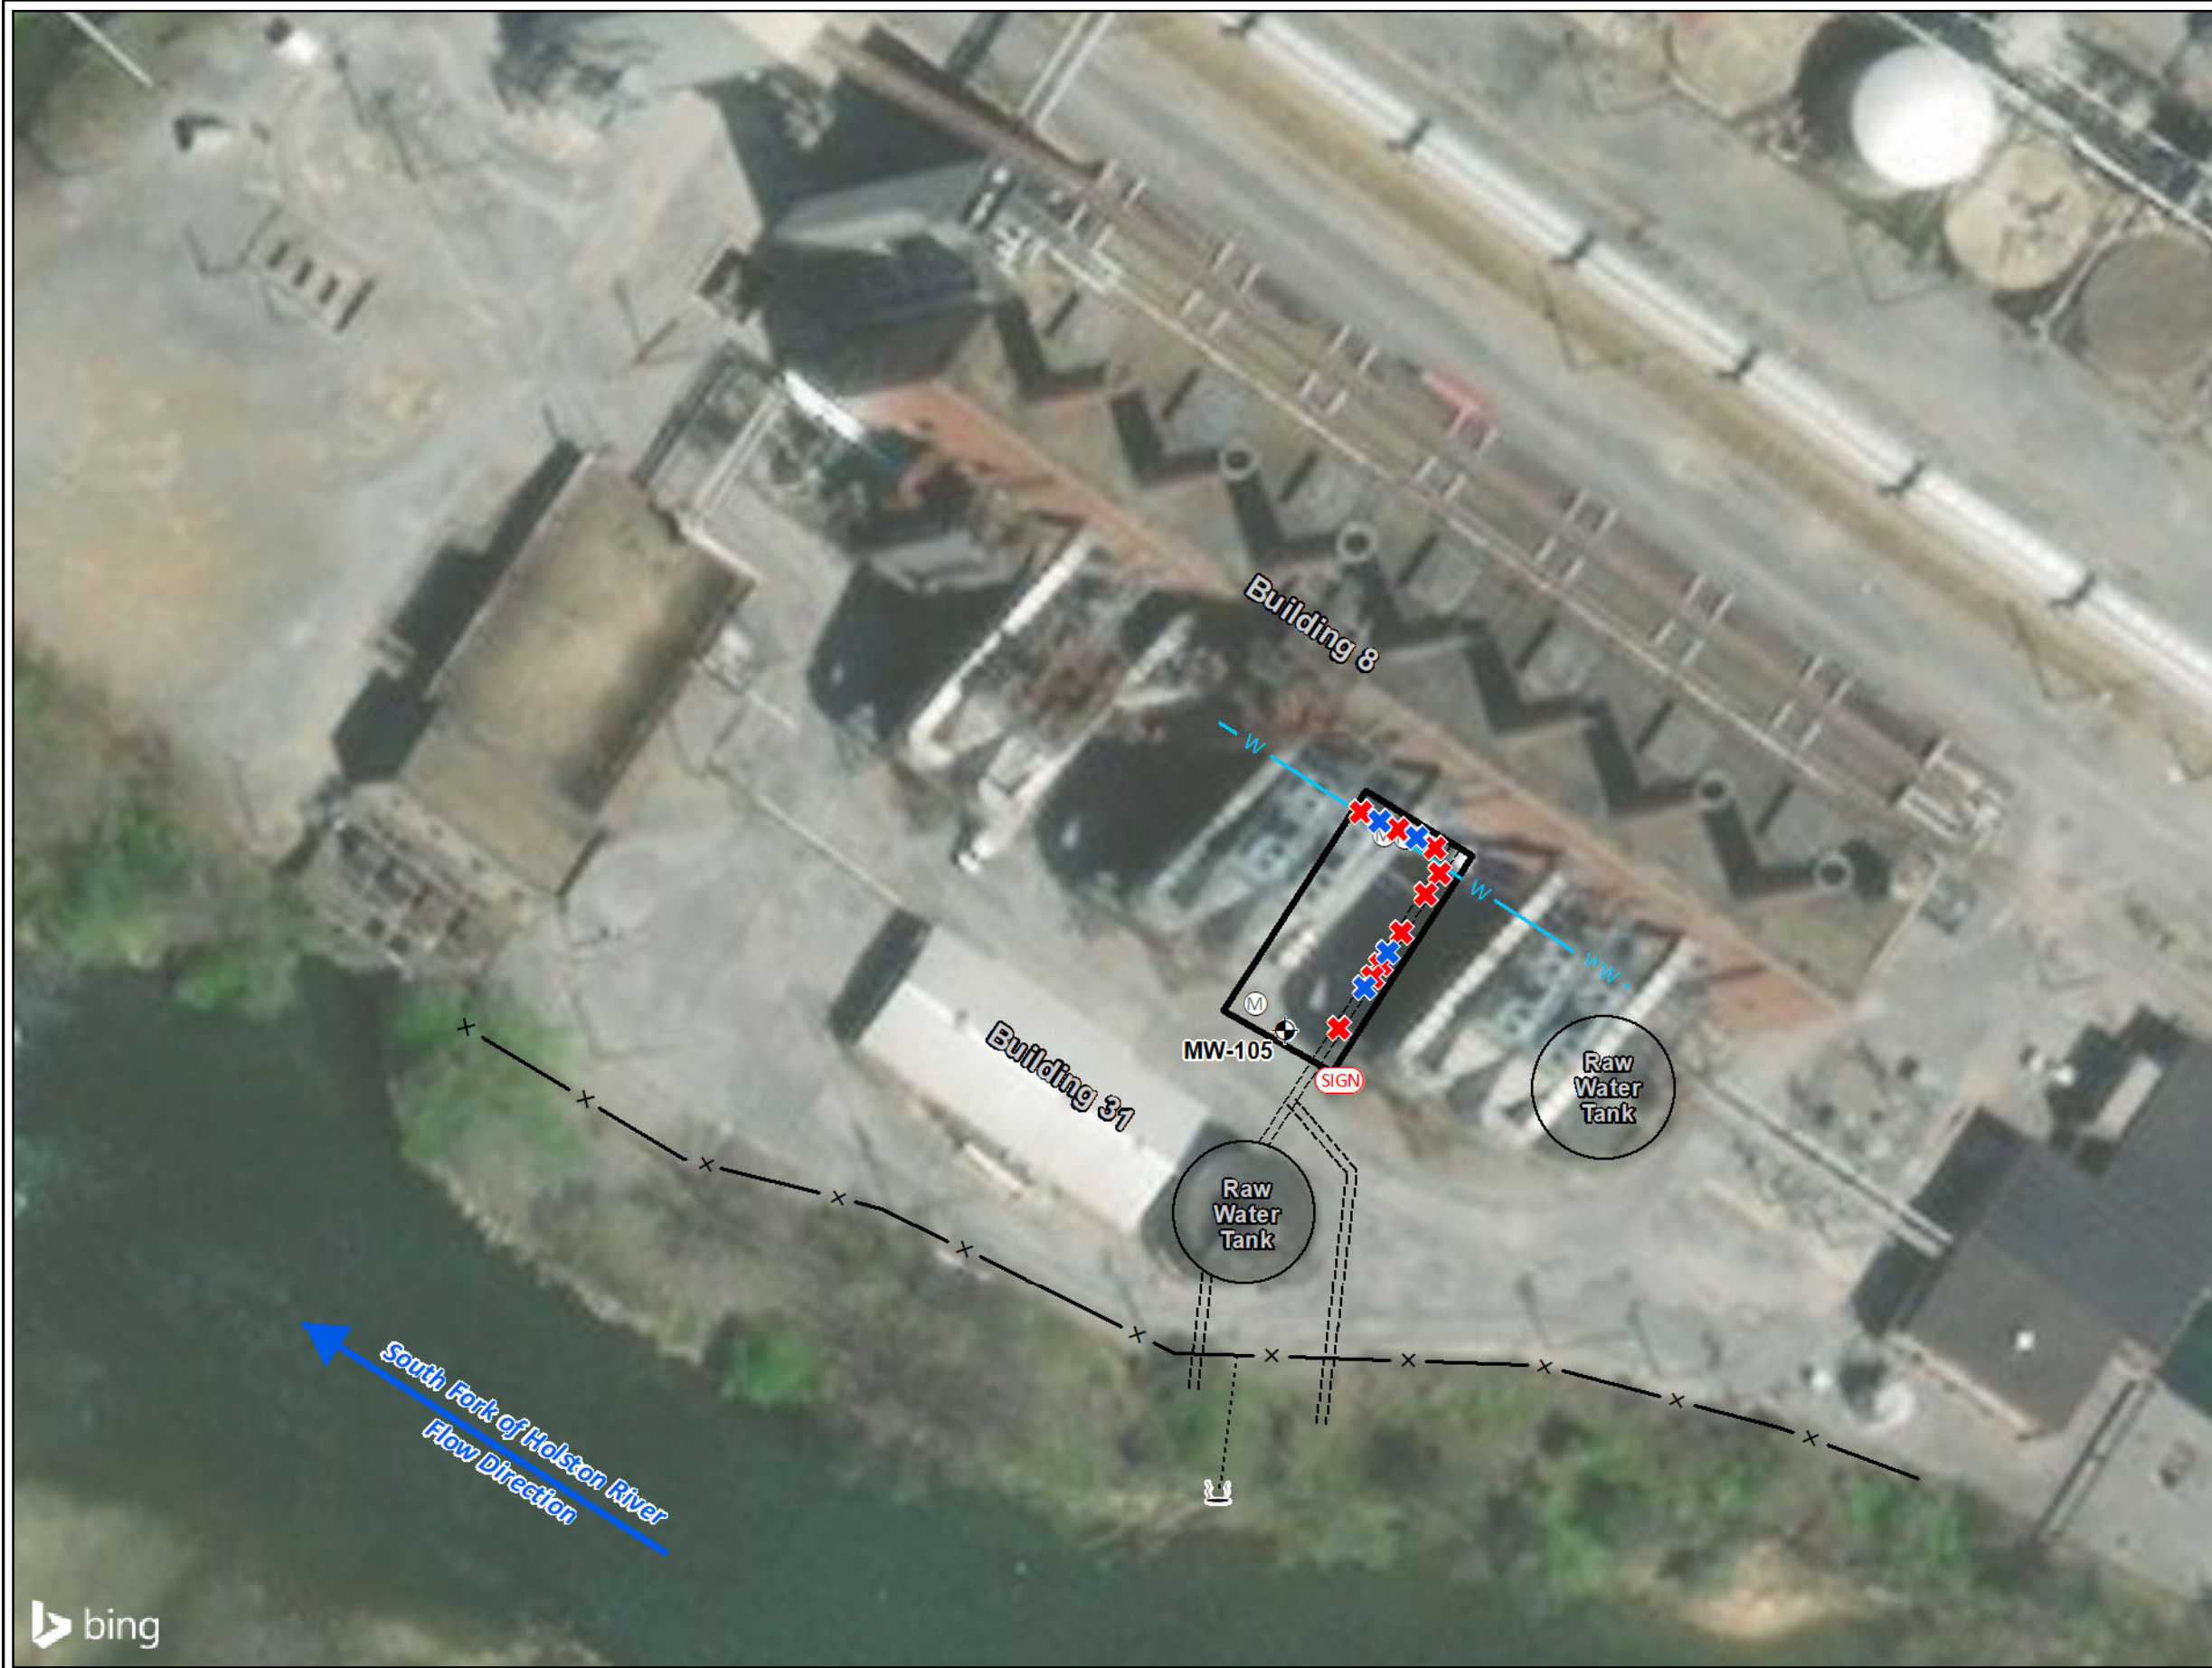
ENGR'G S.M.	DATE	 Bay West <small>Customer-Focused Environmental & Industrial Solutions</small>
DRAWN T.P.	11/22/04	
REV. N.J.	11/06/18	
PROJECT NAME		HSAAP - KINGSPORT, TN
TITLE		SWMU 4 SITE MAP 2018 LTM/LTO REPORT
DWG. NO.	SCALE	FIGURE # 5-2
J160167 2017 FWO	AS SHOWN

- ✖ COAL TAR REMOVED (04/01/18)
- ✖ COAL TAR REMOVED (10/18/18)
- CULVERT
- EXISTING MONITORING WELL
- UTILITY MANHOLES/HATCHES
- SIGN
- CULVERT
- FENCE
- FORMER DITCH APPROXIMATE LOCATION
- TRANSITE WATER LINE
- APPROXIMATE SWMU 4 LIMITS
- RAW WATER TANK

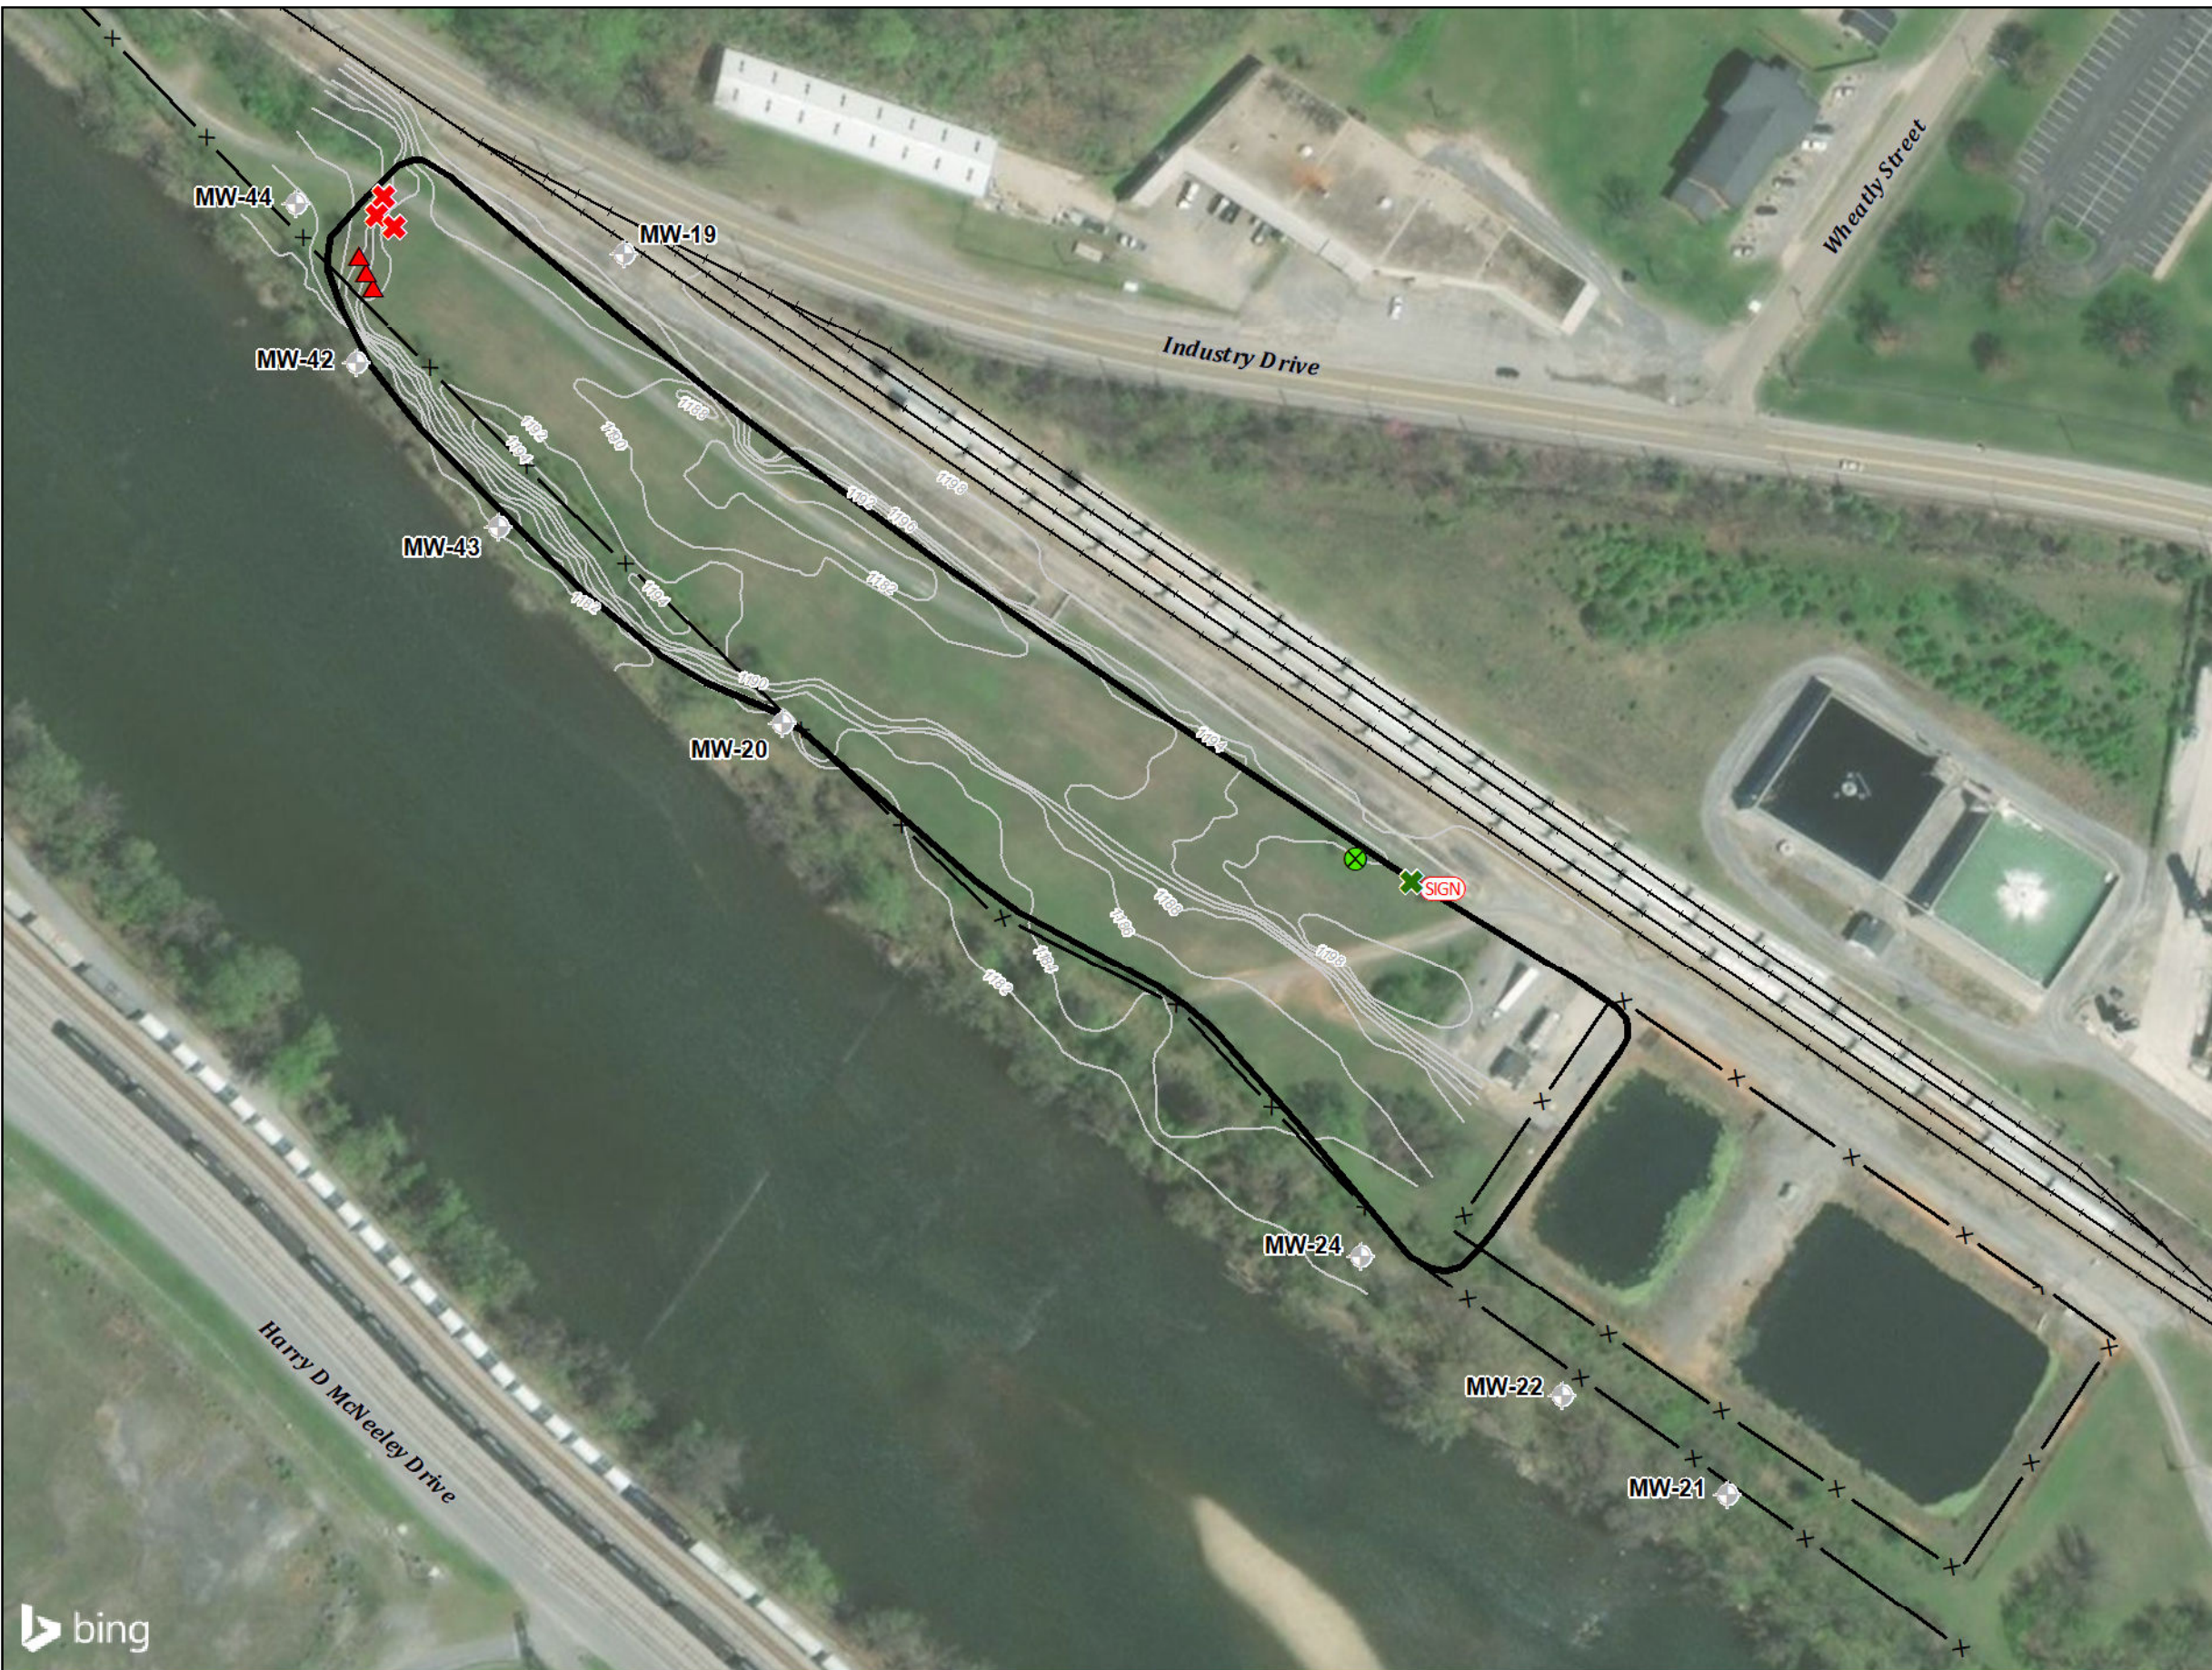
PROJECT NAME		HSAAP - KINGSPORT, TN
TITLE		SWMU 14 SITE MAP 2018 LTM/LTO REPORT
DWG. NO.	SCALE	FIGURE # 5-3
J160167 2017 FWO	AS SHOWN

- ▲ PARTIALLY BURIED PIPES
- ✕ TREES DIRECTLY BEHIND SWMU SIGN
- ✕ COAL TAR REMOVED (04/01/18)
- ⊗ SPROUTING TREES AROUND FIRE HYDRANT (10/18/18)
- + ABANDONED MONITORING WELL
- SIGN SIGN
- APPROXIMATE SWMU 14 LANDFILL LIMITS
- ✕ FENCE
- + RAILROAD
- GROUND SURFACE ELEVATION CONTOUR IN FEET

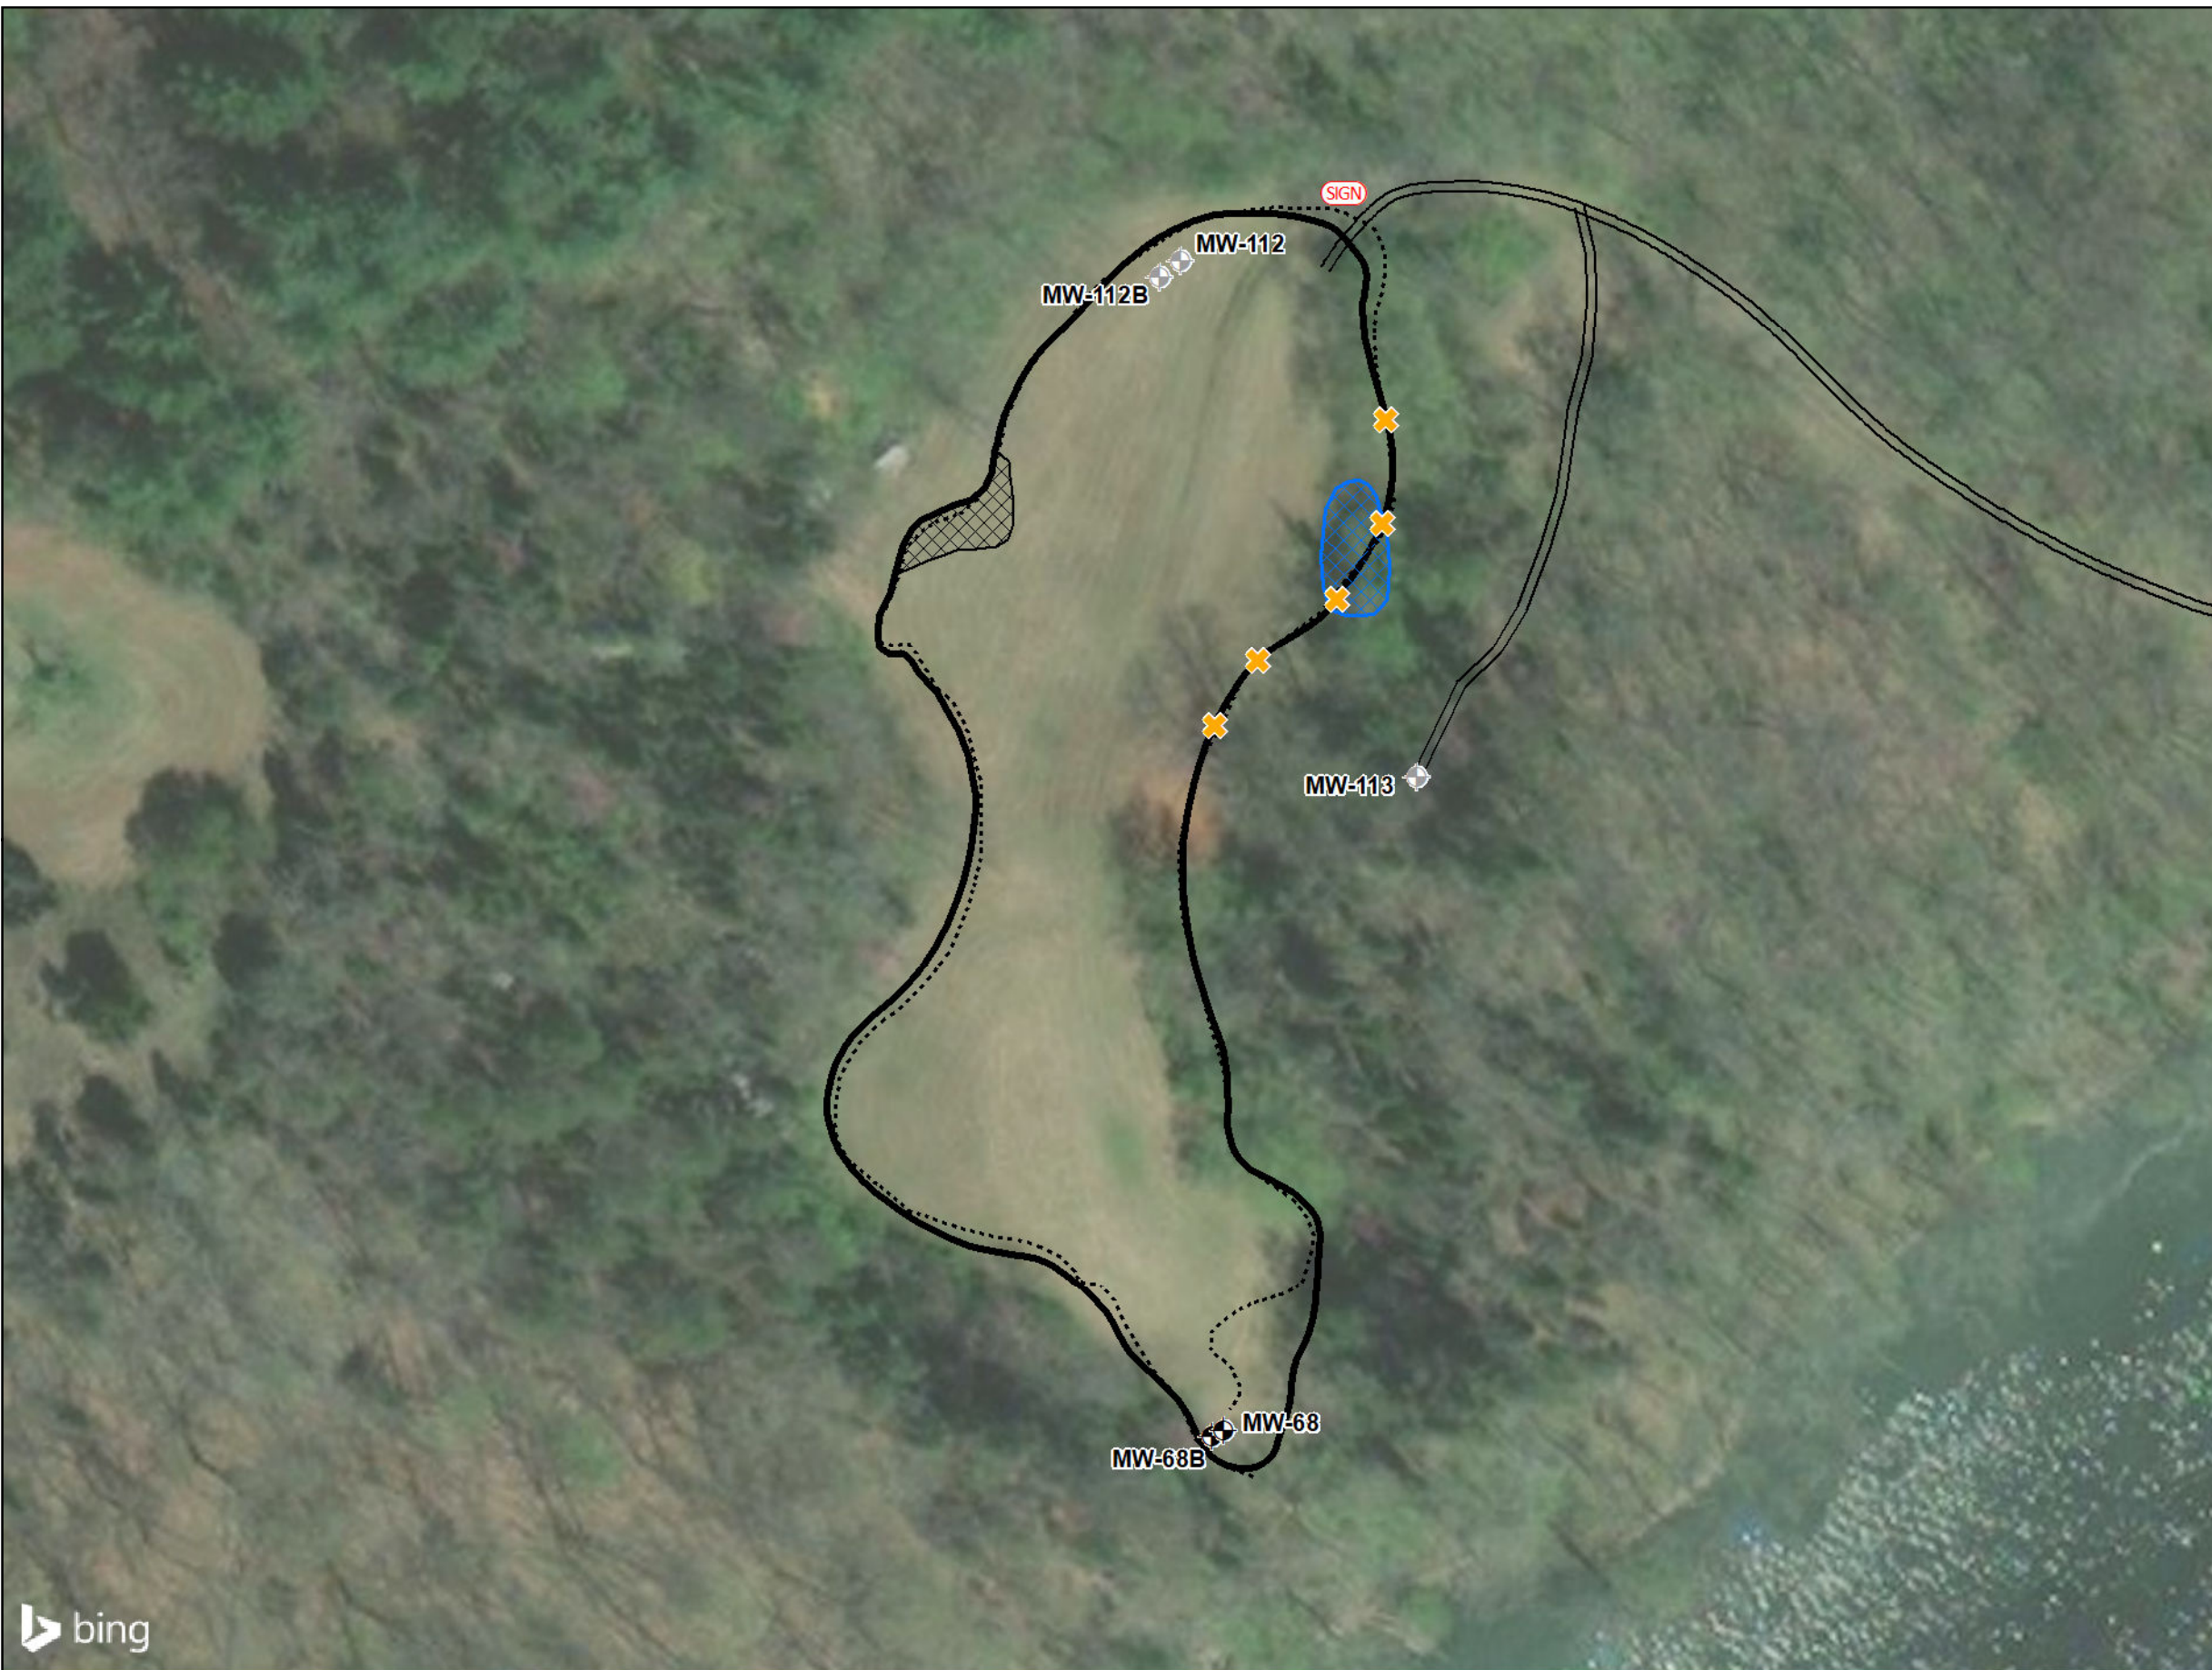
ENGR'G S.M.	DATE	
DRAWN T.P.	11/22/04	
REV. N.J.	11/06/18	
PROJECT NAME		HSAAP - KINGSPORT, TN
TITLE		SWMU 20 SITE MAP 2018 LTM/LTO REPORT
DWG. NO.	SCALE	FIGURE # 5-6
J160167 2017 FWO	AS SHOWN

VARIOUS BRICKS & ORANGE TERRA COTTA PIPE
	ABANDONED MONITORING WELL
	EXISTING MONITORING WELL
	SIGN
	SURFACE DRAINAGE WITH RIPRAP
	ACCESS ROAD (UNPAVED)
	DEBRIS OBSERVED (10/18/18)
	ROCK SLIDE
	APPROXIMATE SWMU 20 LANDFILL LIMITS

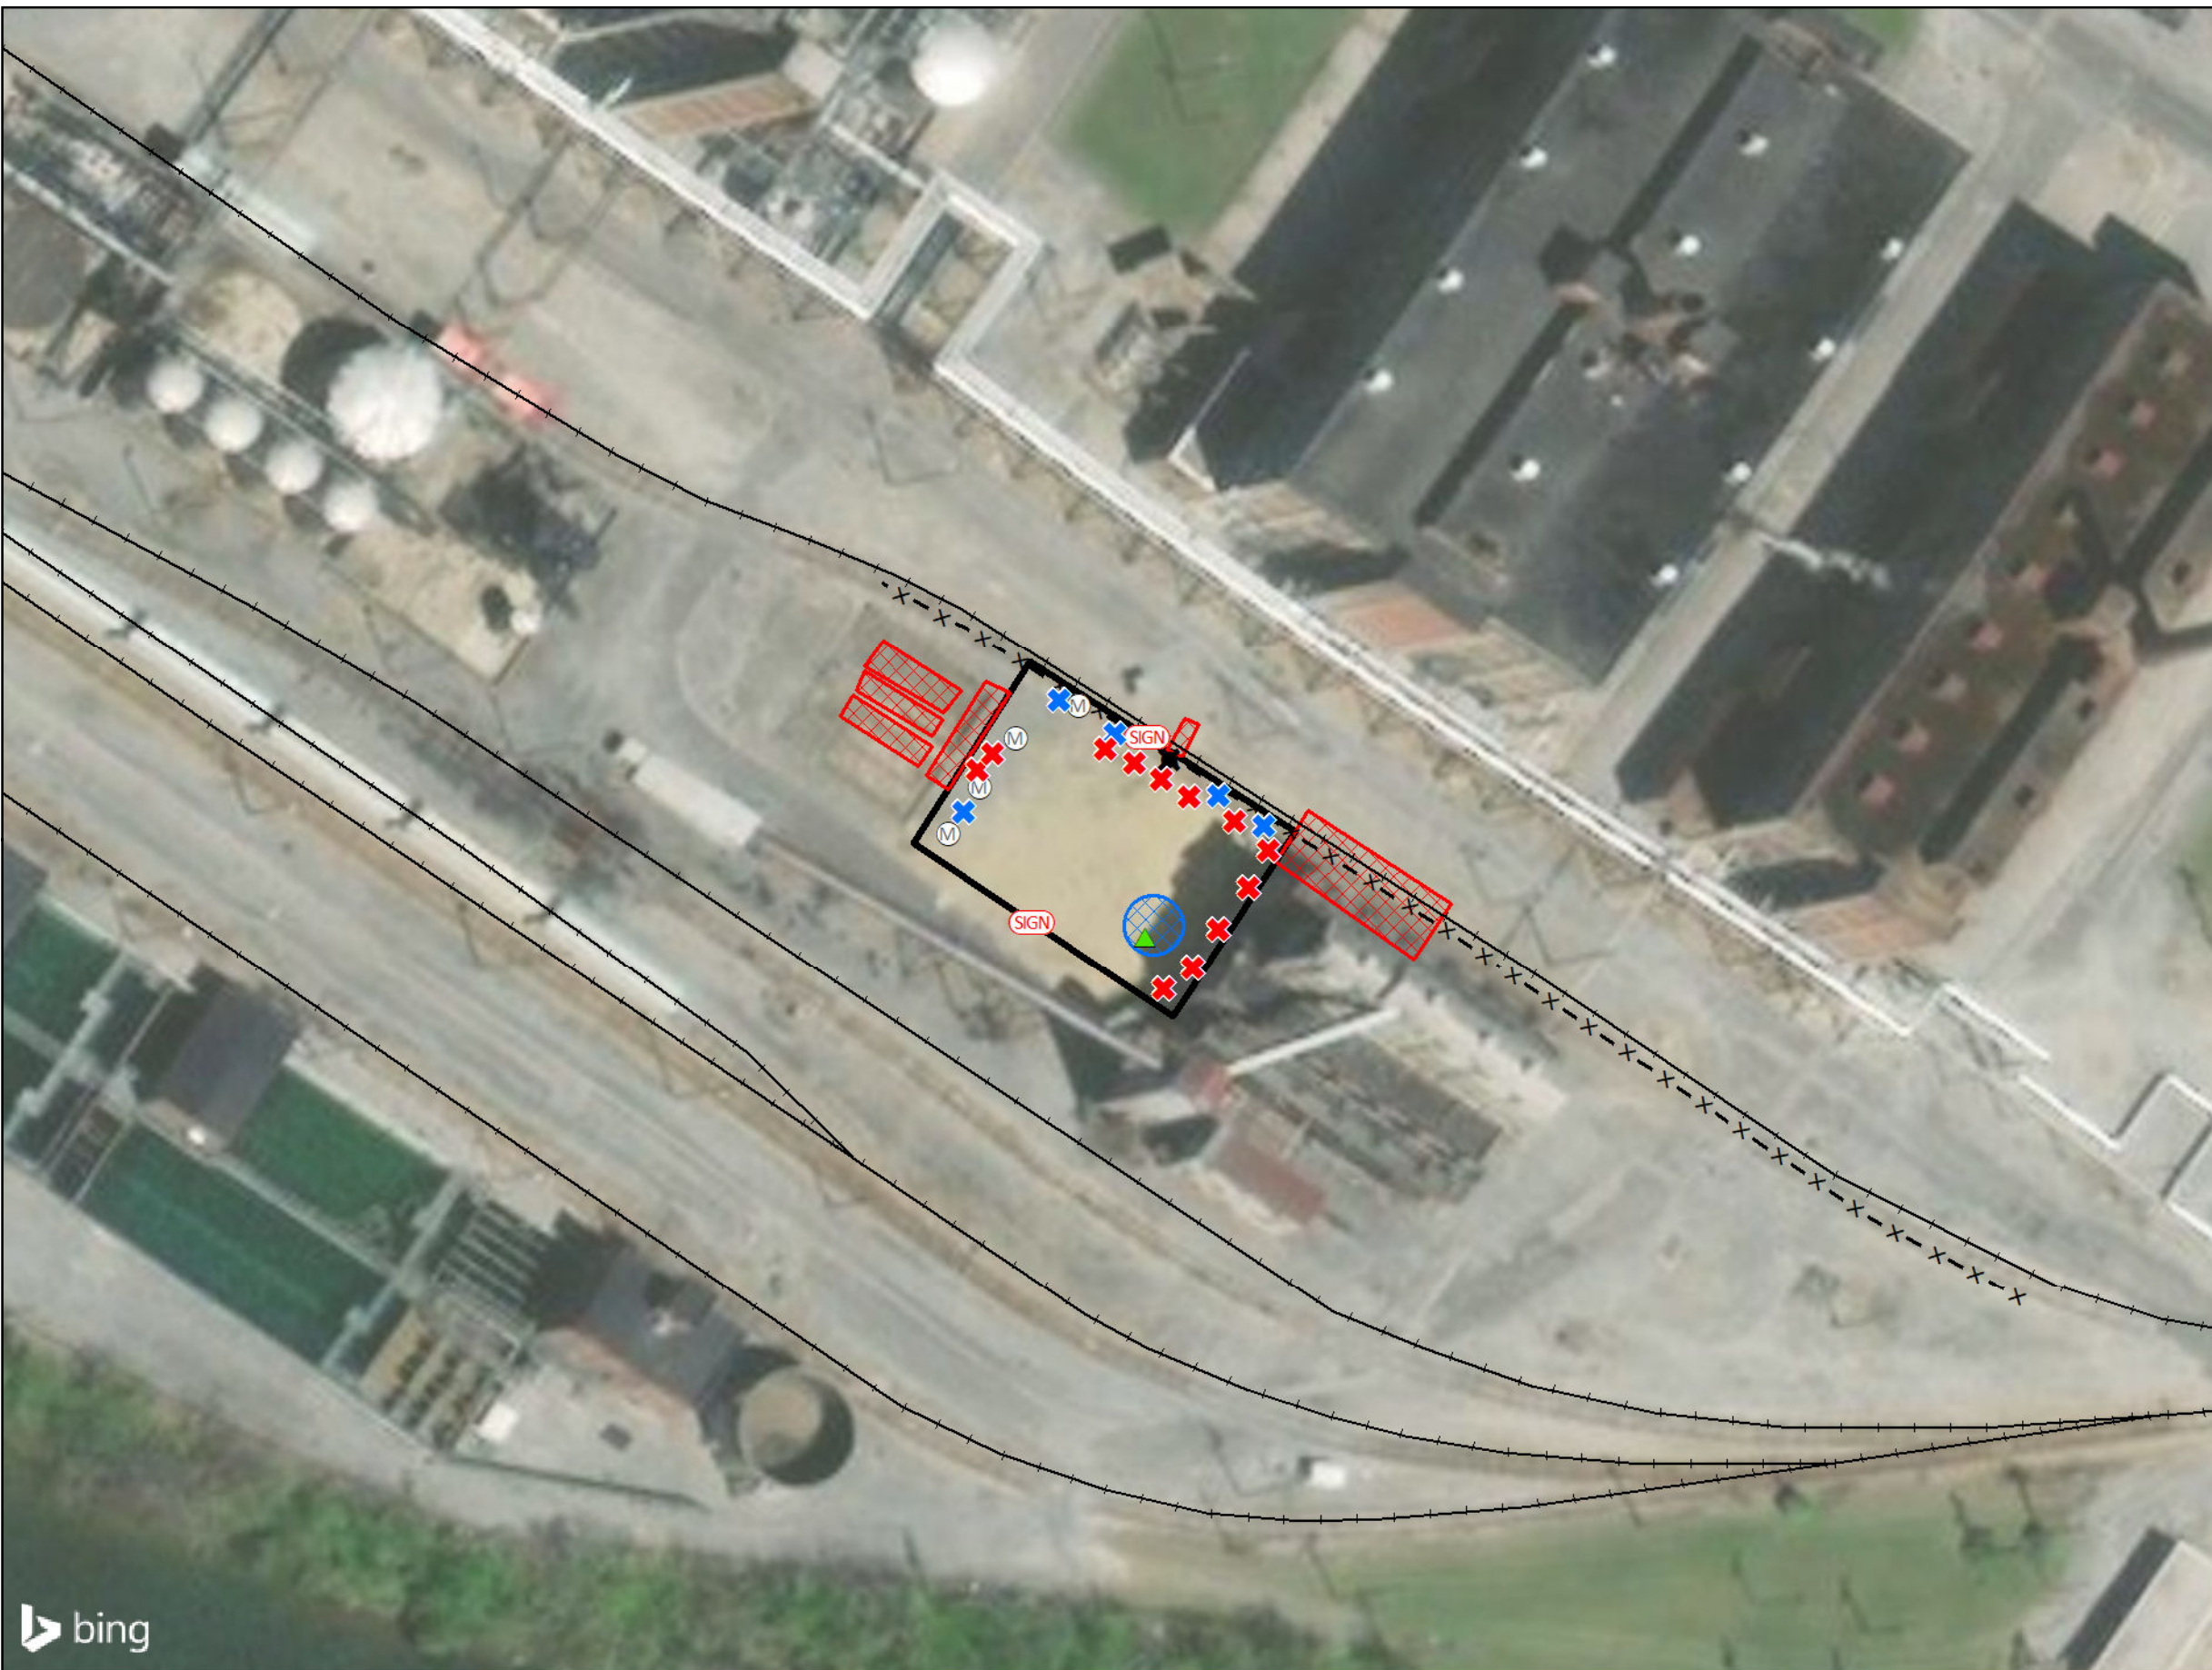
ENGR'G S.M.	DATE	Bay West Customer-Focused Environmental & Industrial Solutions
DRAWN T.P.	11/22/04	
REV. N.J.	11/06/18	
PROJECT NAME		HSAAP - KINGSPORT, TN
TITLE		SWMU 96 SITE MAP 2018 LTM/LTO REPORT
DWG. NO.	SCALE	FIGURE # 5-8
J160167 2017 FWO	AS SHOWN

- ACM TRANSITE TILE
- COAL TAR REMOVED (04/01/18)
- COAL TAR REMOVED (10/18/18)
- LOCATION OF REMOVED SHEET METAL
- UTILITY MANHOLES/HATCHES
- SIGN
- LOCATION OF NEW FENCE LINE FOR EASTMAN ACCESS
- RAILROAD
- STANDING SURFACE WATER (10/18/18)
- AREA WITH ENCRUSTED COAL TAR
- APPROXIMATE SWMU 96 LANDFILL LIMITS

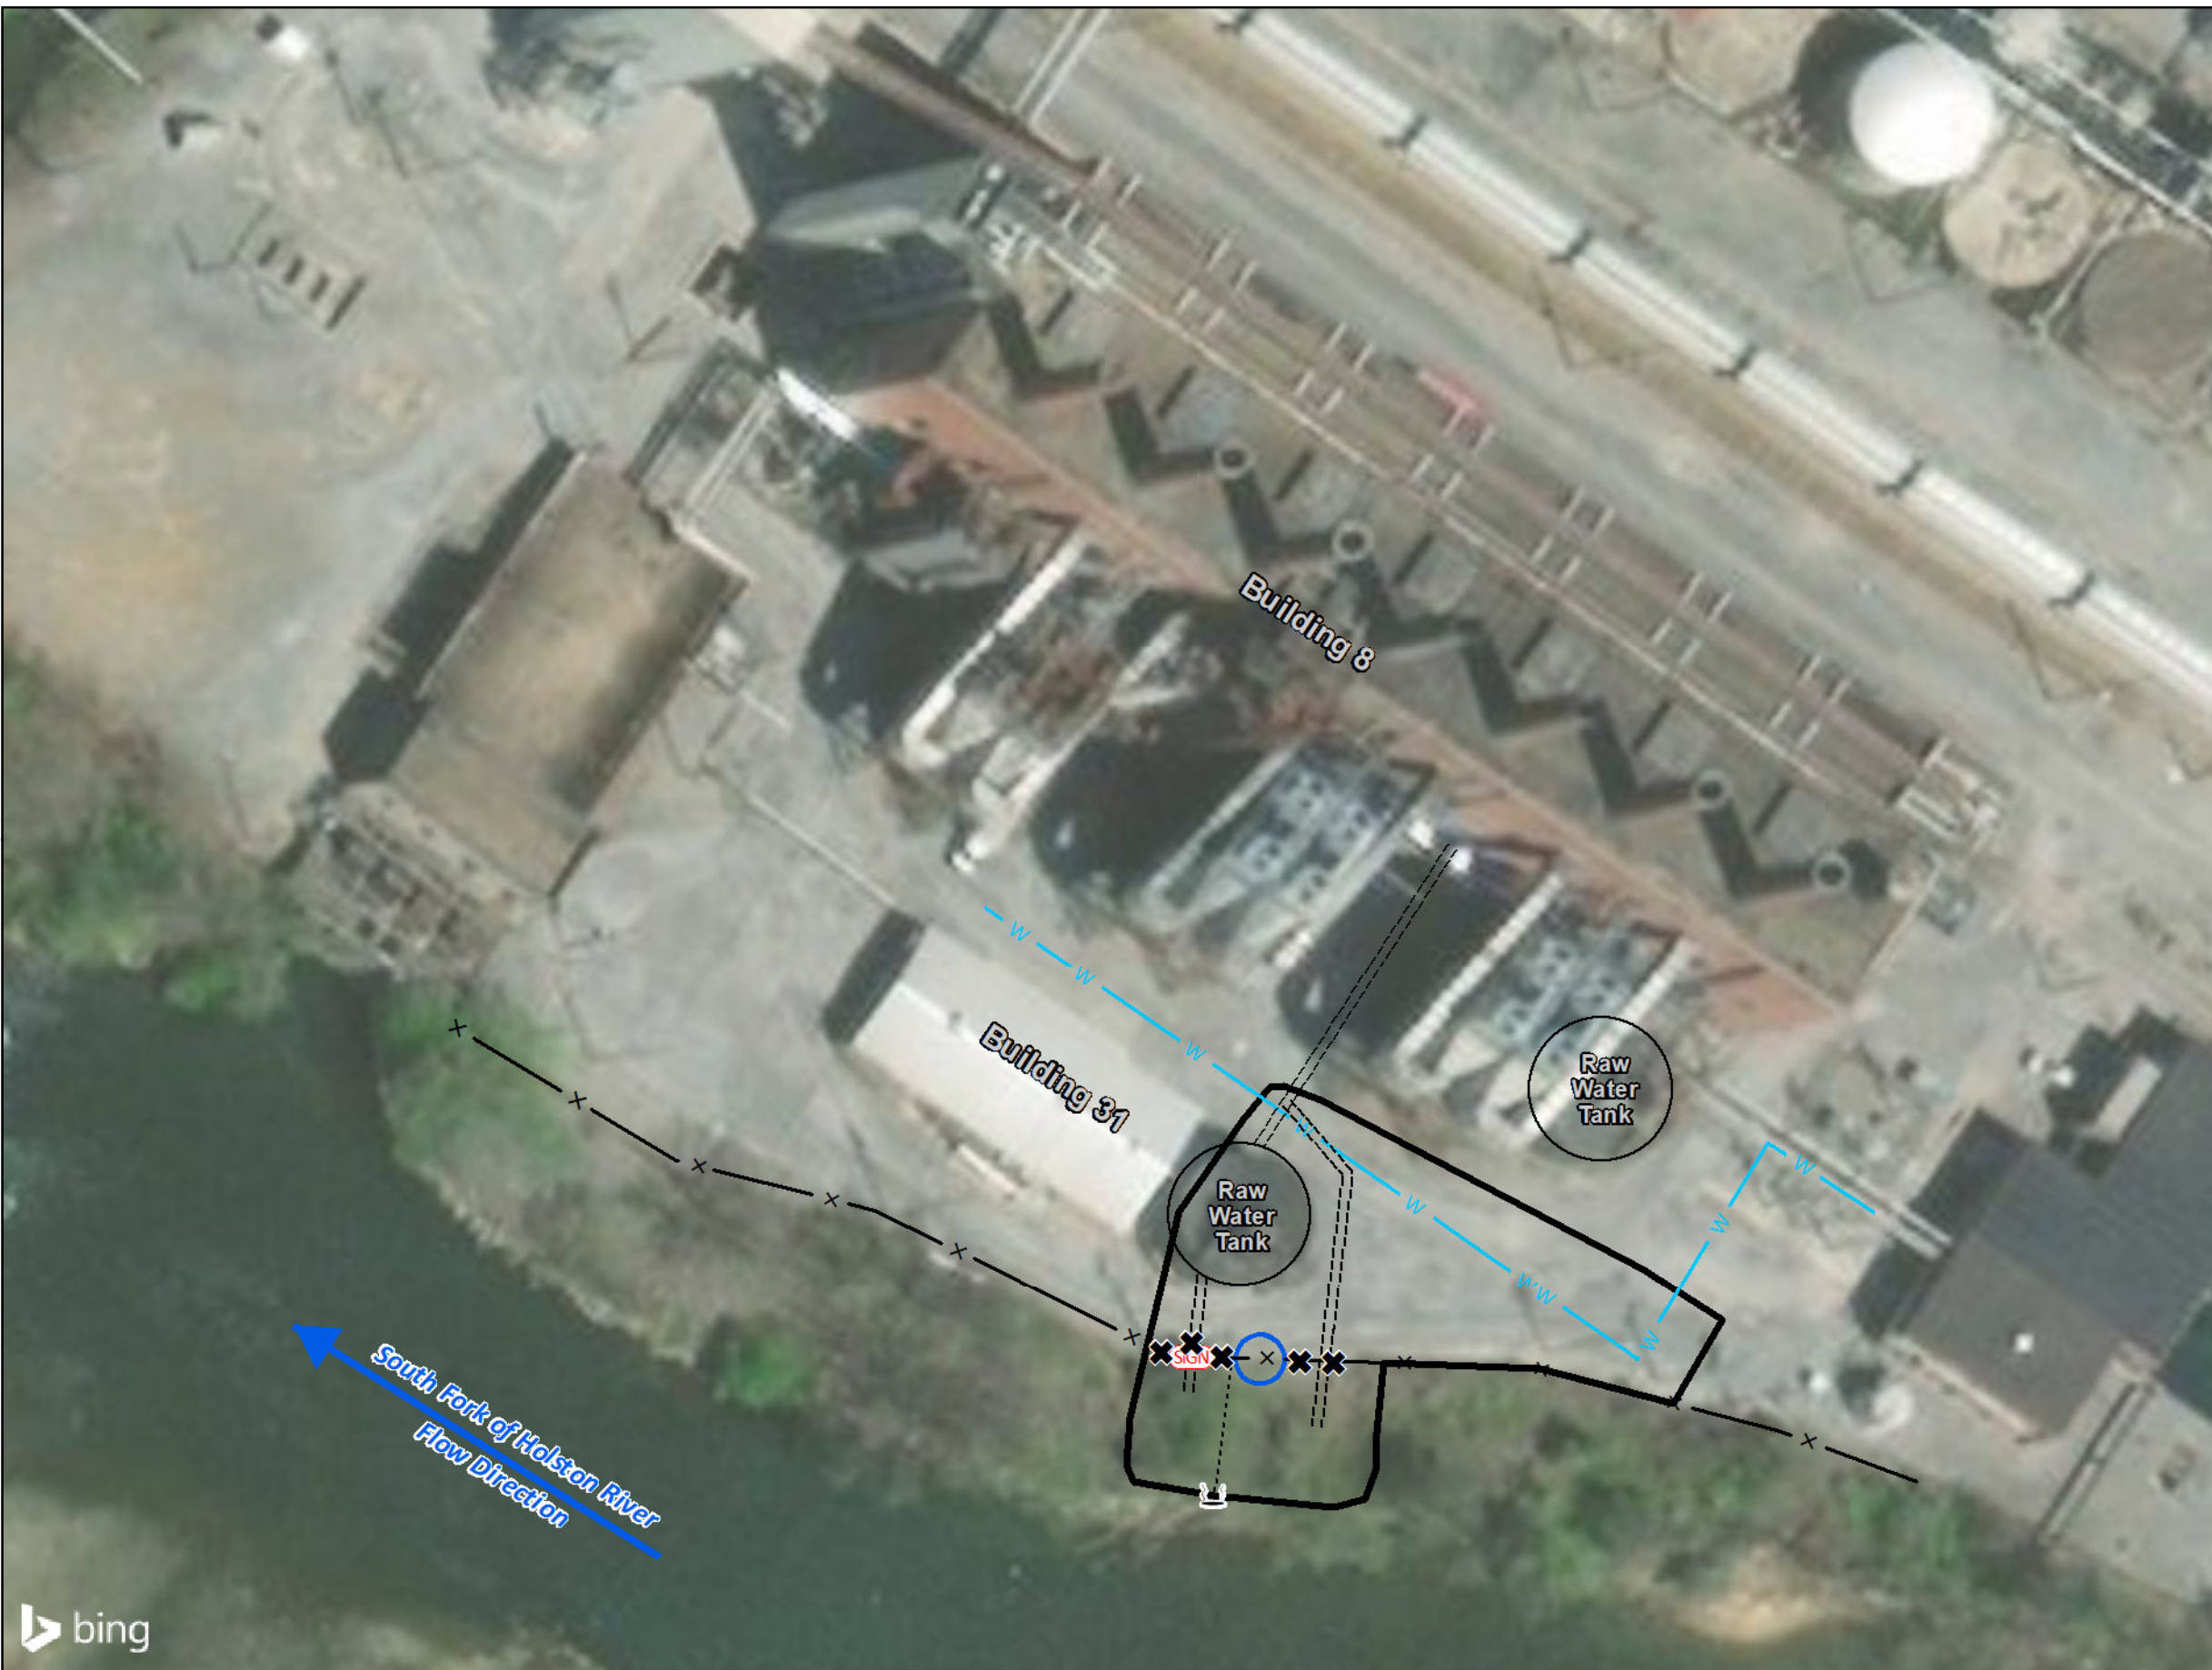
<i>Customer-Focused Environmental & Industrial Solutions</i>
DRAWN T.P.	11/22/04	
REV. N.J.	11/06/18	
PROJECT NAME		HSAAP - KINGSPORT, TN
TITLE		SWMU 103 SITE MAP 2018 LTM/LTO REPORT
DWG. NO.	SCALE	FIGURE # 5-9
J160167 2017 FWO	AS SHOWN

- ✘ COAL TAR REMOVED (04/01/18)
- ⎓ CULVERT
- (SIGN) SIGN
- W — APPROXIMATE WATER LINE LOCATION
- CULVERT
- x — FENCE
- FORMER DITCH APPROXIMATE LOCATION
- LARGE MASS OF COAL TAR REMOVED (04/01/18)
- APPROXIMATE SWMU 103 LIMITS
- RAW WATER TANK

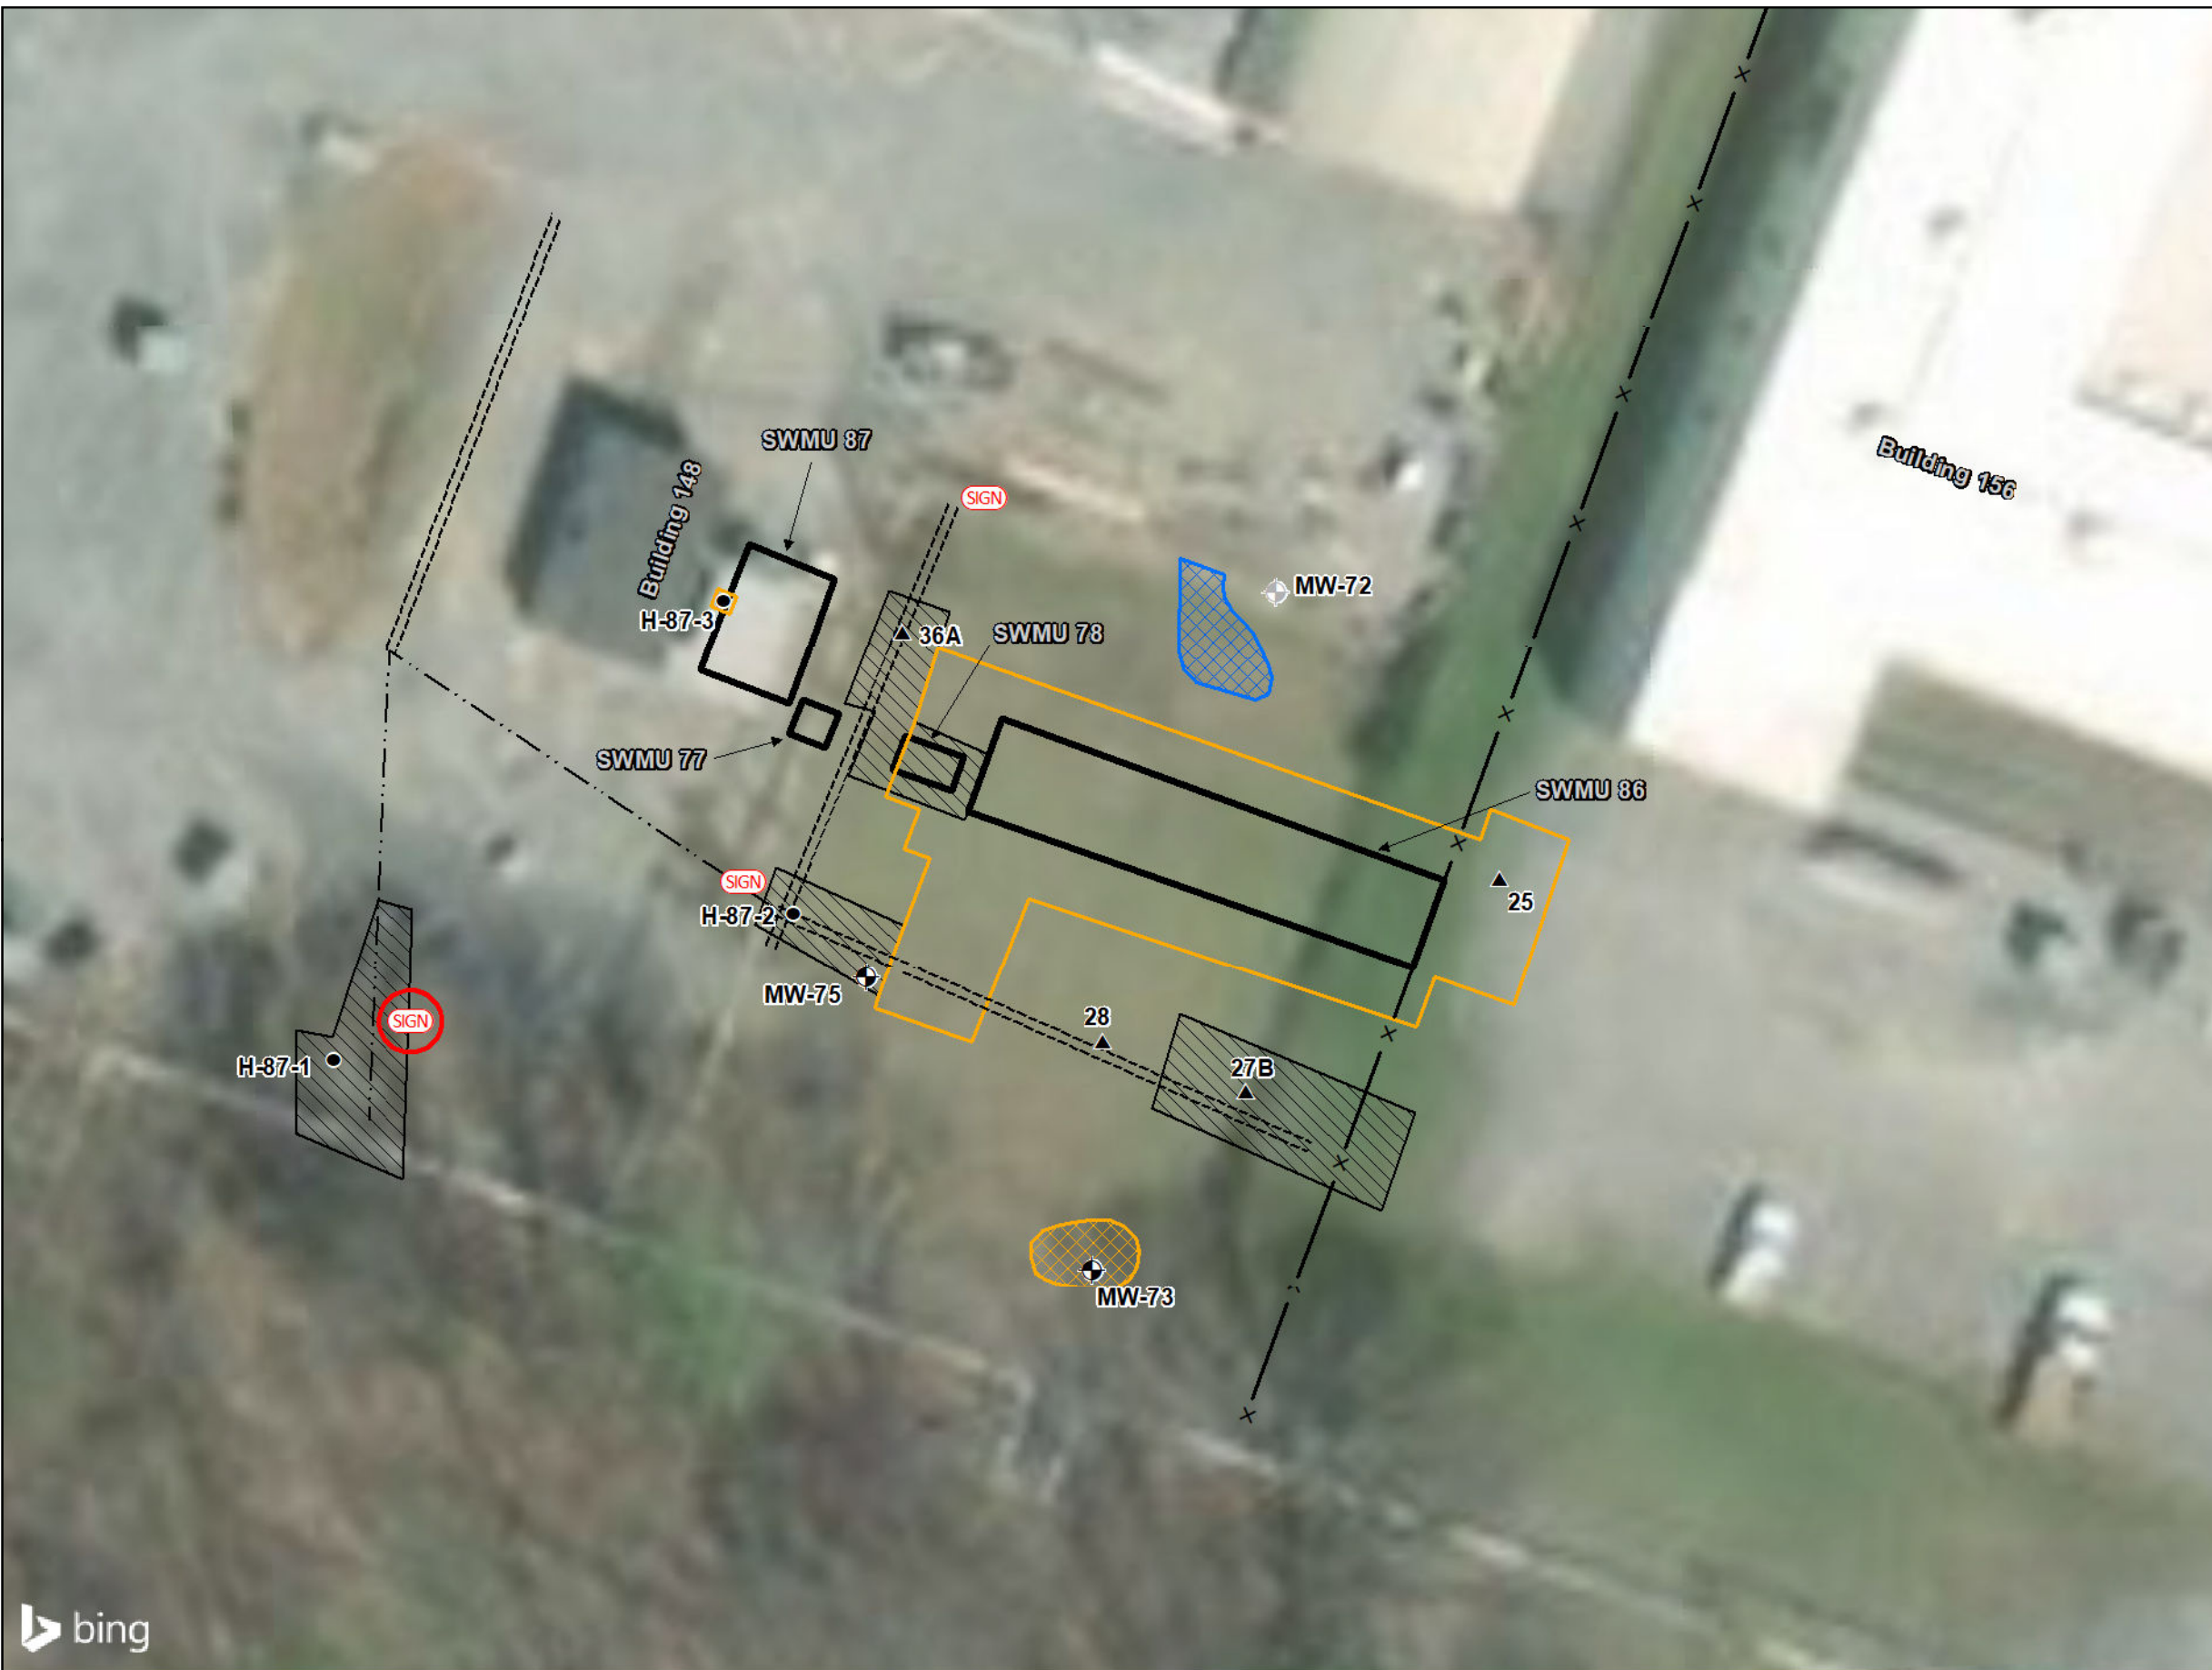
ENGR'G S.M.	DATE	Bay West Customer-Focused Environmental & Industrial Solutions
DRAWN T.P.	11/22/04	
REV. N.J.	11/06/18	
PROJECT NAME		HSAAP - KINGSPORT, TN
TITLE		SWMU 77/78/86/87 SITE MAP 2018 LTM/LTO REPORT
DWG. NO.	SCALE	FIGURE # 5-10
J160167 2017 FWO	AS SHOWN

- 2003 SOIL SAMPLE LOCATIONS
- ABANDONED MONITORING WELL
- EXISTING MONITORING WELL
- MAY 1997 SURFACE SOIL SAMPLE LOCATIONS
- SIGN
- 10" PIPE
- DITCH
- FENCE
- STANDING SURFACE WATER - 03/26/18 (NOT OBSERVED ON 10/15/18)
- REPAIRED SWMU SIGN (04/03/18)
- AREA BARE OF VEGETATION (10/15/18)
- APPROXIMATE SWMU LIMITS
- AREA OF RESTRICTED EXCAVATION
- LIMIT OF EXCAVATIONS
